JAPC provides Tsuruga-2 leak findings to NSC

Thermal stresses were determined to be the cause of cracks in a pipe elbow and a regenerative heat exchanger connected to the top of the elbow.

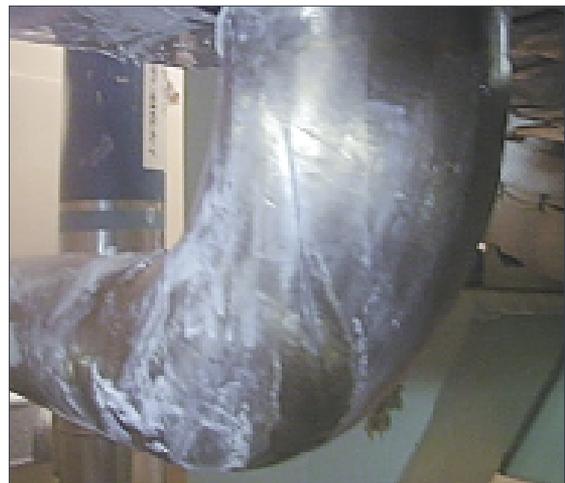
The utility concluded that 11 cracks inside the leaking pipe elbow (including the 47-mm-long and 0.2-mm-wide penetrating crack) and five other crack-like marks inside a regenerative heat exchanger connected to the top of the elbow were caused by thermal stresses

from hot-and-cold water cycling in the heat exchanger.

The pipe elbow with the vertical crack that caused the July 12 leak at Tsuruga-2 in Japan (JAPC Photo)

ter flow on one side of the flow pass between the shell and cylinder, and, accordingly, less space on the other side. In its technical evaluation, JAPC noted that if the wider space allows more flow and thus more heat, the cylinder wall on that side accordingly would expand more than the other side, choking the flow accordingly. If the flow were choked, it then would lead to less flow, less heat, and thus less expansion of the wall and a net movement of the wall in a direction back to creating a wider space—then, again more flow and more heat, etc. The resulting hot-and-cold mixed flow, produced at the end of the inner cylinder, entered the pipe elbow in question.

This cycling phenomenon of flow is believed to have occurred at a frequency of once

every 10 to 20 minutes, resulting in thermal stress of about 11 kg/mm² in the affected areas on the heat exchanger and its connecting elbow, for 10⁶ cycles over the period of plant operation to date. Tsuruga-2, an 1115-MWe pressurized water reactor, began commercial operation in February 1987.

To correct the situation, JAPC plans to replace the heat exchangers with a new design, without inner cylinders—if and when its ongoing technical evaluation recommends this, and the licensing authority concurs—during a year-end scheduled plant inspection. Originally set for December 1999–January 2000, this inspection has been moved up to November–December 1999. The plant will remain shut down until that inspection is completed.

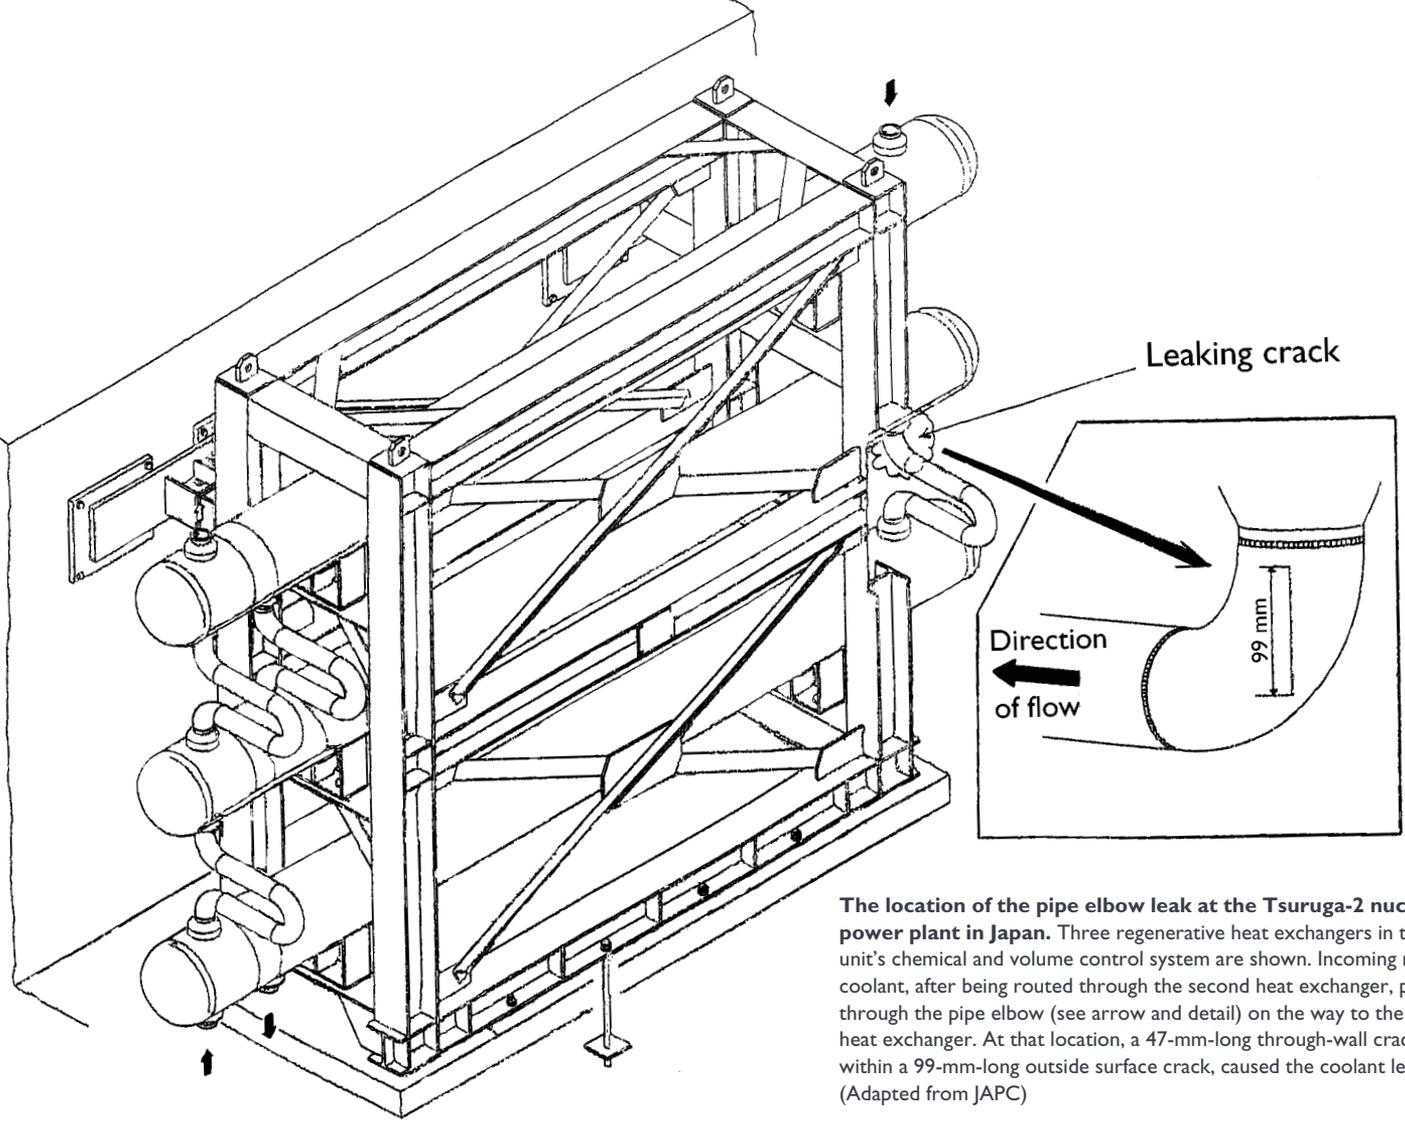
The five crack-like marks were on the inside surface of the second heat-exchanger shell, around the outlet of the inner cylinder. JAPC has found that the inner cylinder was positioned more than 1 mm off center at support ring number 2 near the end of the inner cylinder, thus providing more space for wa-

The location of the pipe elbow leak at the Tsuruga-2 nuclear power plant in Japan. Three regenerative heat exchangers in the unit's chemical and volume control system are shown. Incoming reactor coolant, after being routed through the second heat exchanger, passed through the pipe elbow (see arrow and detail) on the way to the third heat exchanger. At that location, a 47-mm-long through-wall crack, within a 99-mm-long outside surface crack, caused the coolant leak. (Adapted from JAPC)
