# Event Sequence After the Earthquake

ANS Annual Meeting, Hollywood, Fl., USA

Hisashi Ninokata  
Tokyo Institute of Technology  
Tokyo, Japan

# What happened to Fukushima-Daichi NP Station – an outline

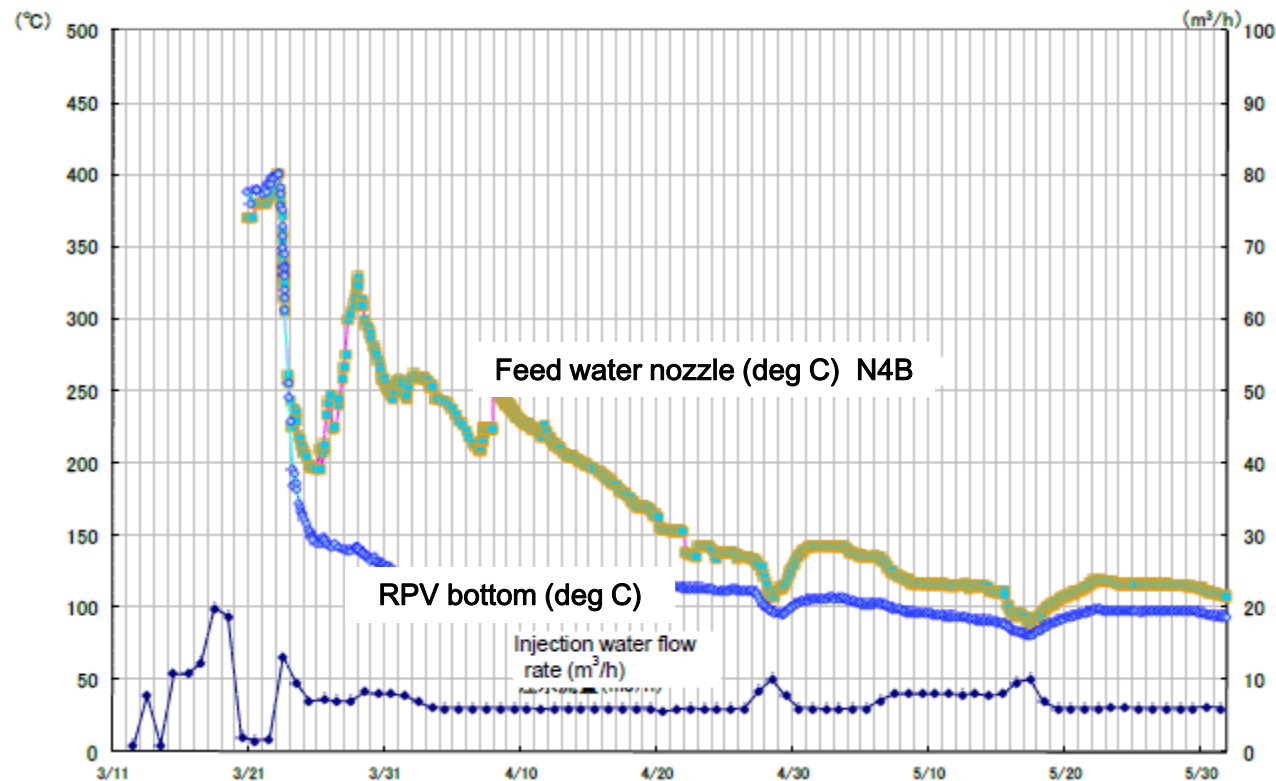
Figure IV-5-1 Changes in major parameters [1F-1] (From March 11 to May 31)

# 1F1 Temperatures (March 21~)

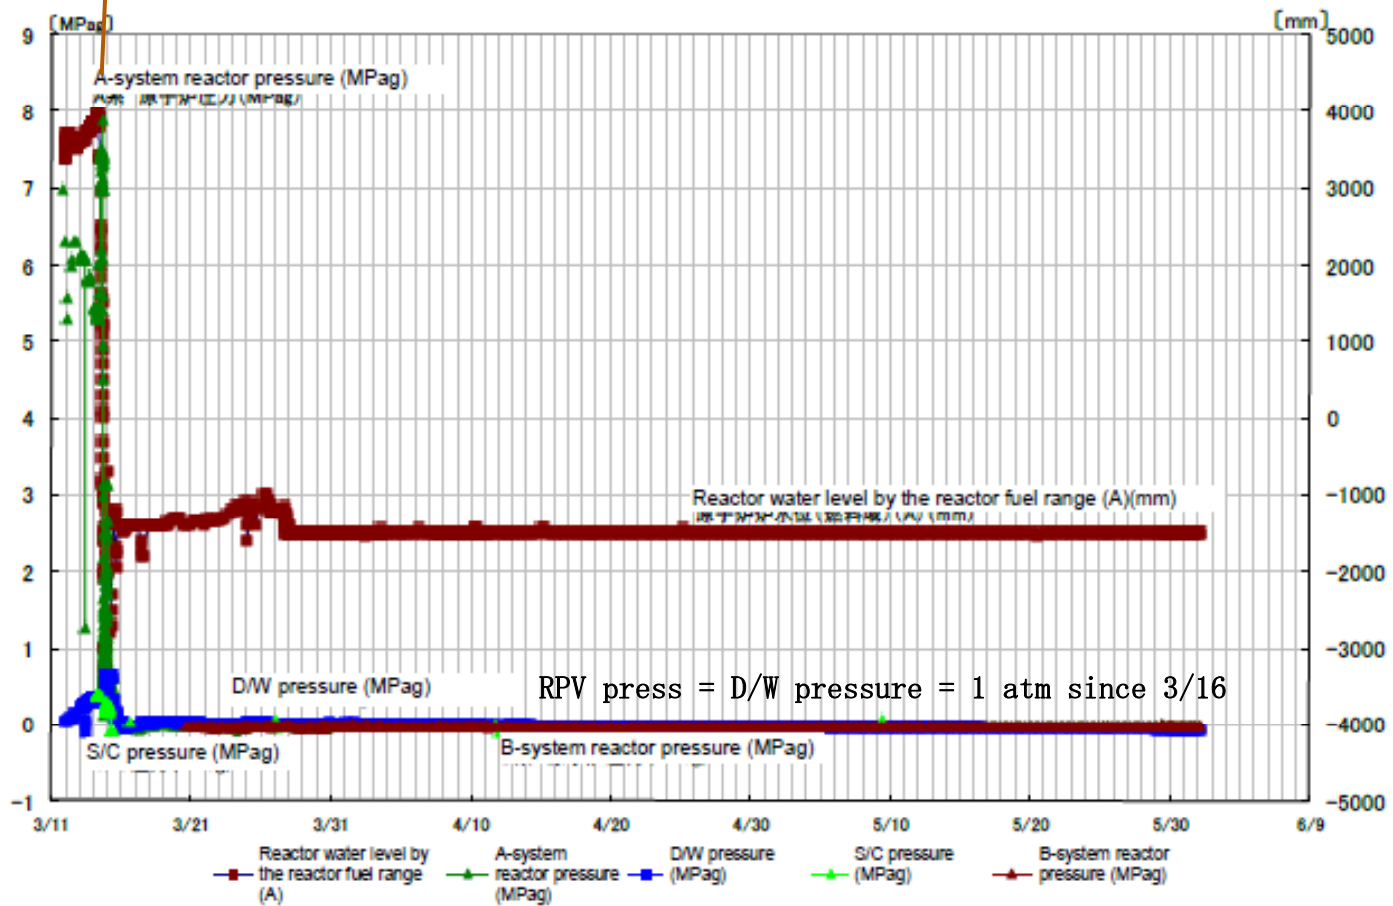
# 1F2 Water level and pressures (long term)

3/14  
RCIC/HPCI  
stopped

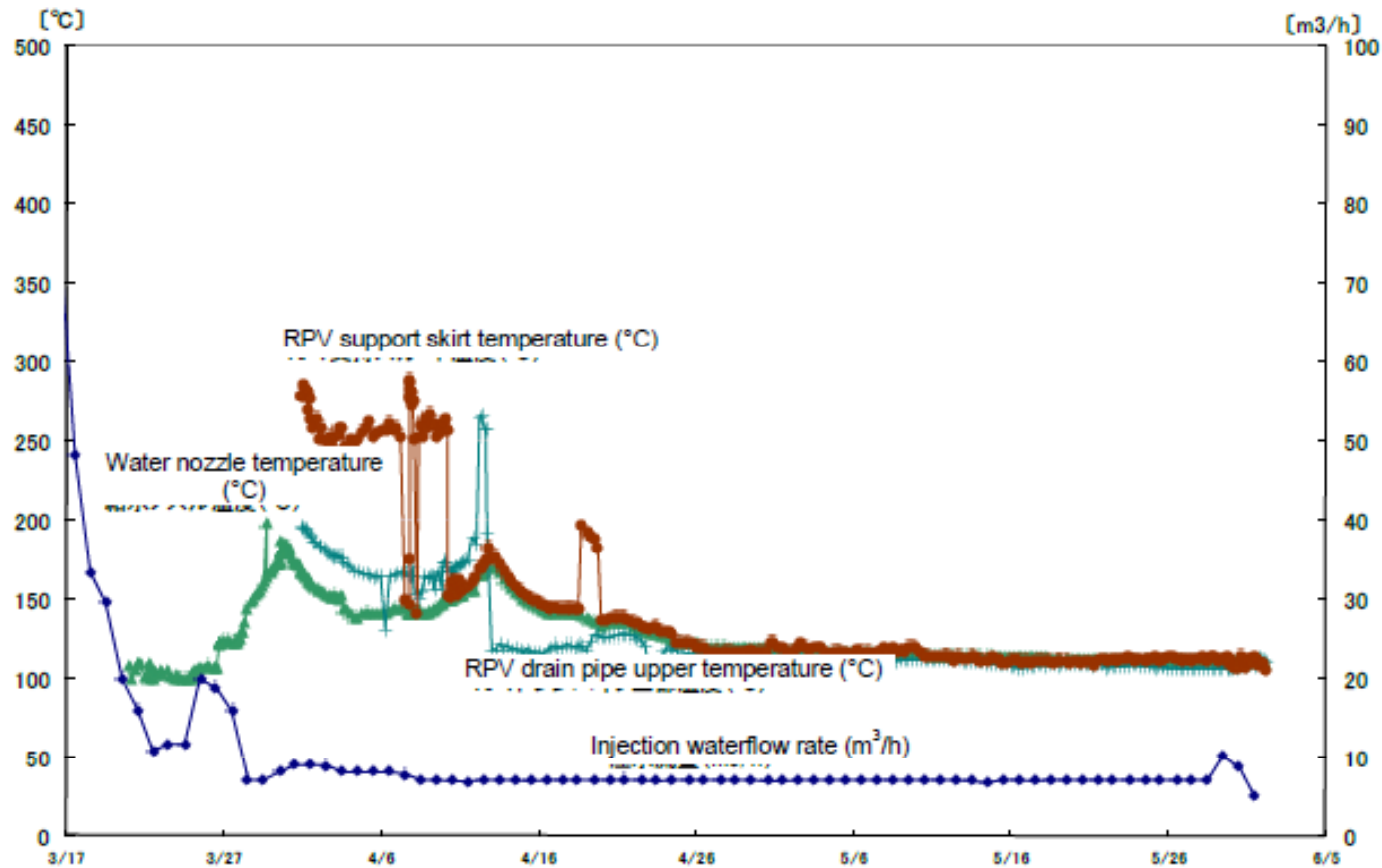
Fig. IV-5-6 Changes in key parameters [1F-2] (From March 17 to May 31)

# 1F2 RPV support skirt temperature

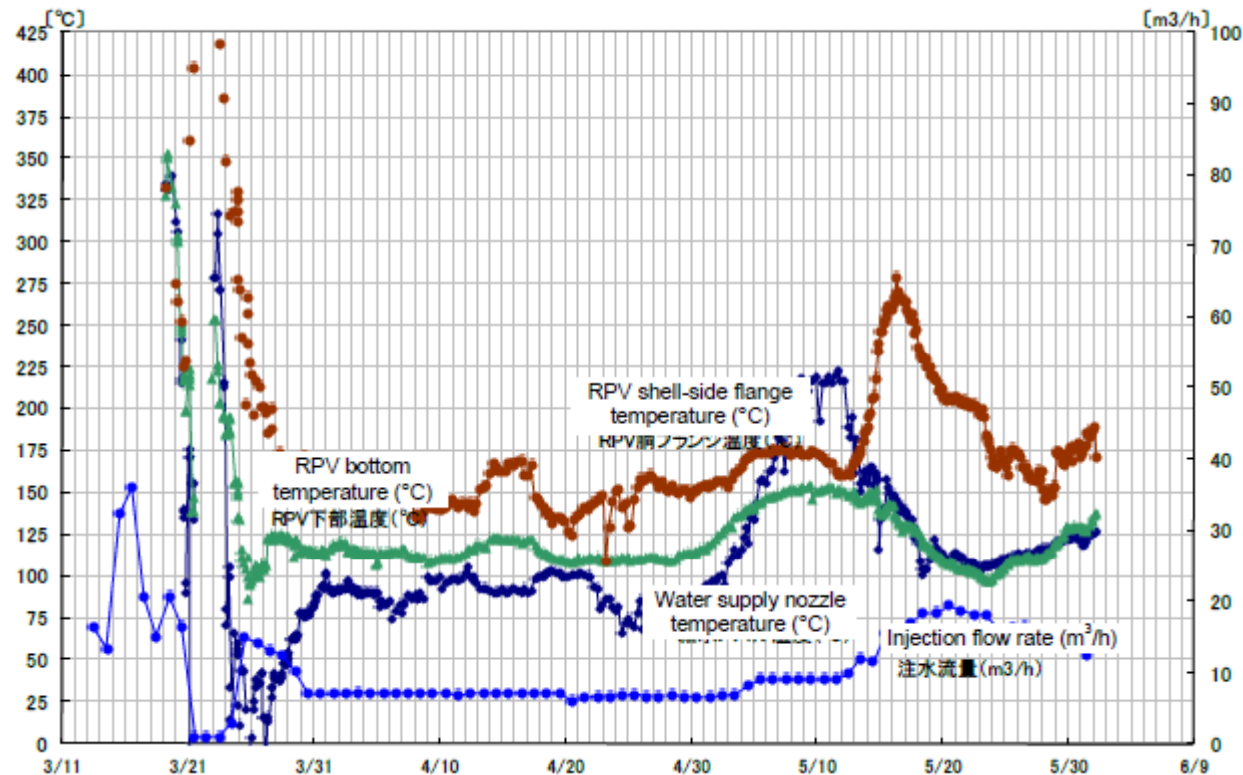
Figure IV-5-7 Changes of Main Parameters (1F-3) (March 11 to May 31)

# 1F3 RPV and D/W temperatures, water level (long range)
