# The March 2011 Earthquake and Tsunami in Japan: A Perspective

Mary Lou Dunzik-Gougar, PhD  
Associate Professor of Nuclear Engineering  
Idaho state University  
and

Executive Committee of the Fuel Cycle and Waste Management Division  
American Nuclear Society

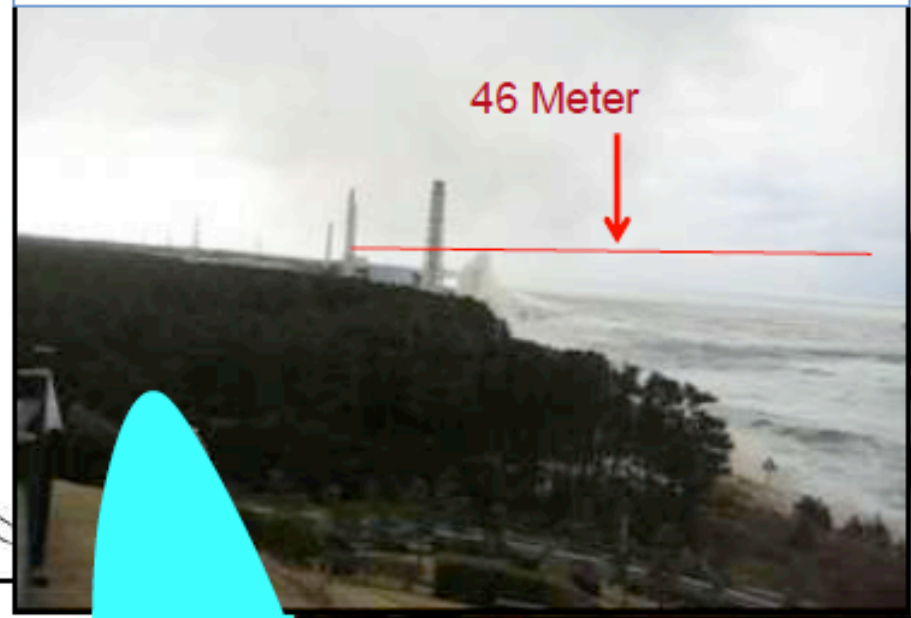
## Huge Tsunami

**Tsunami (estimated 14m)**

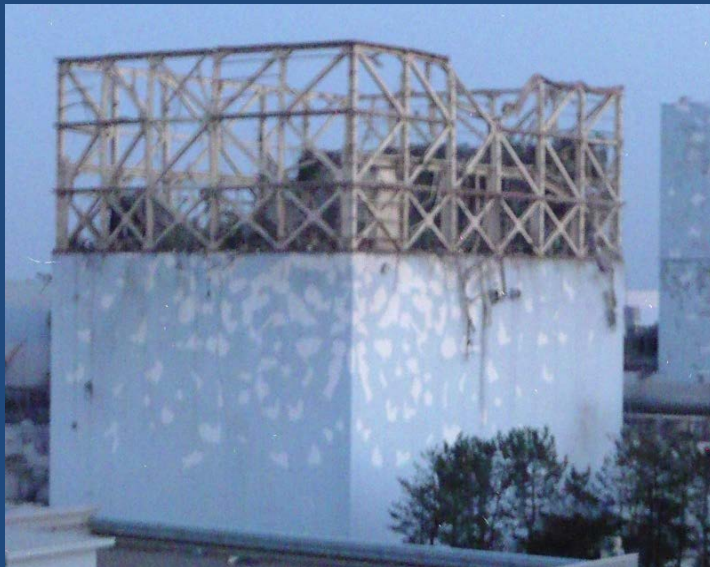
# H<sub>2</sub> explosions

## ▣ Units 1 and 3 service areas

- ◆ Steel frame roof destroyed
- ◆ Concrete building intact
- ◆ Seawater injected

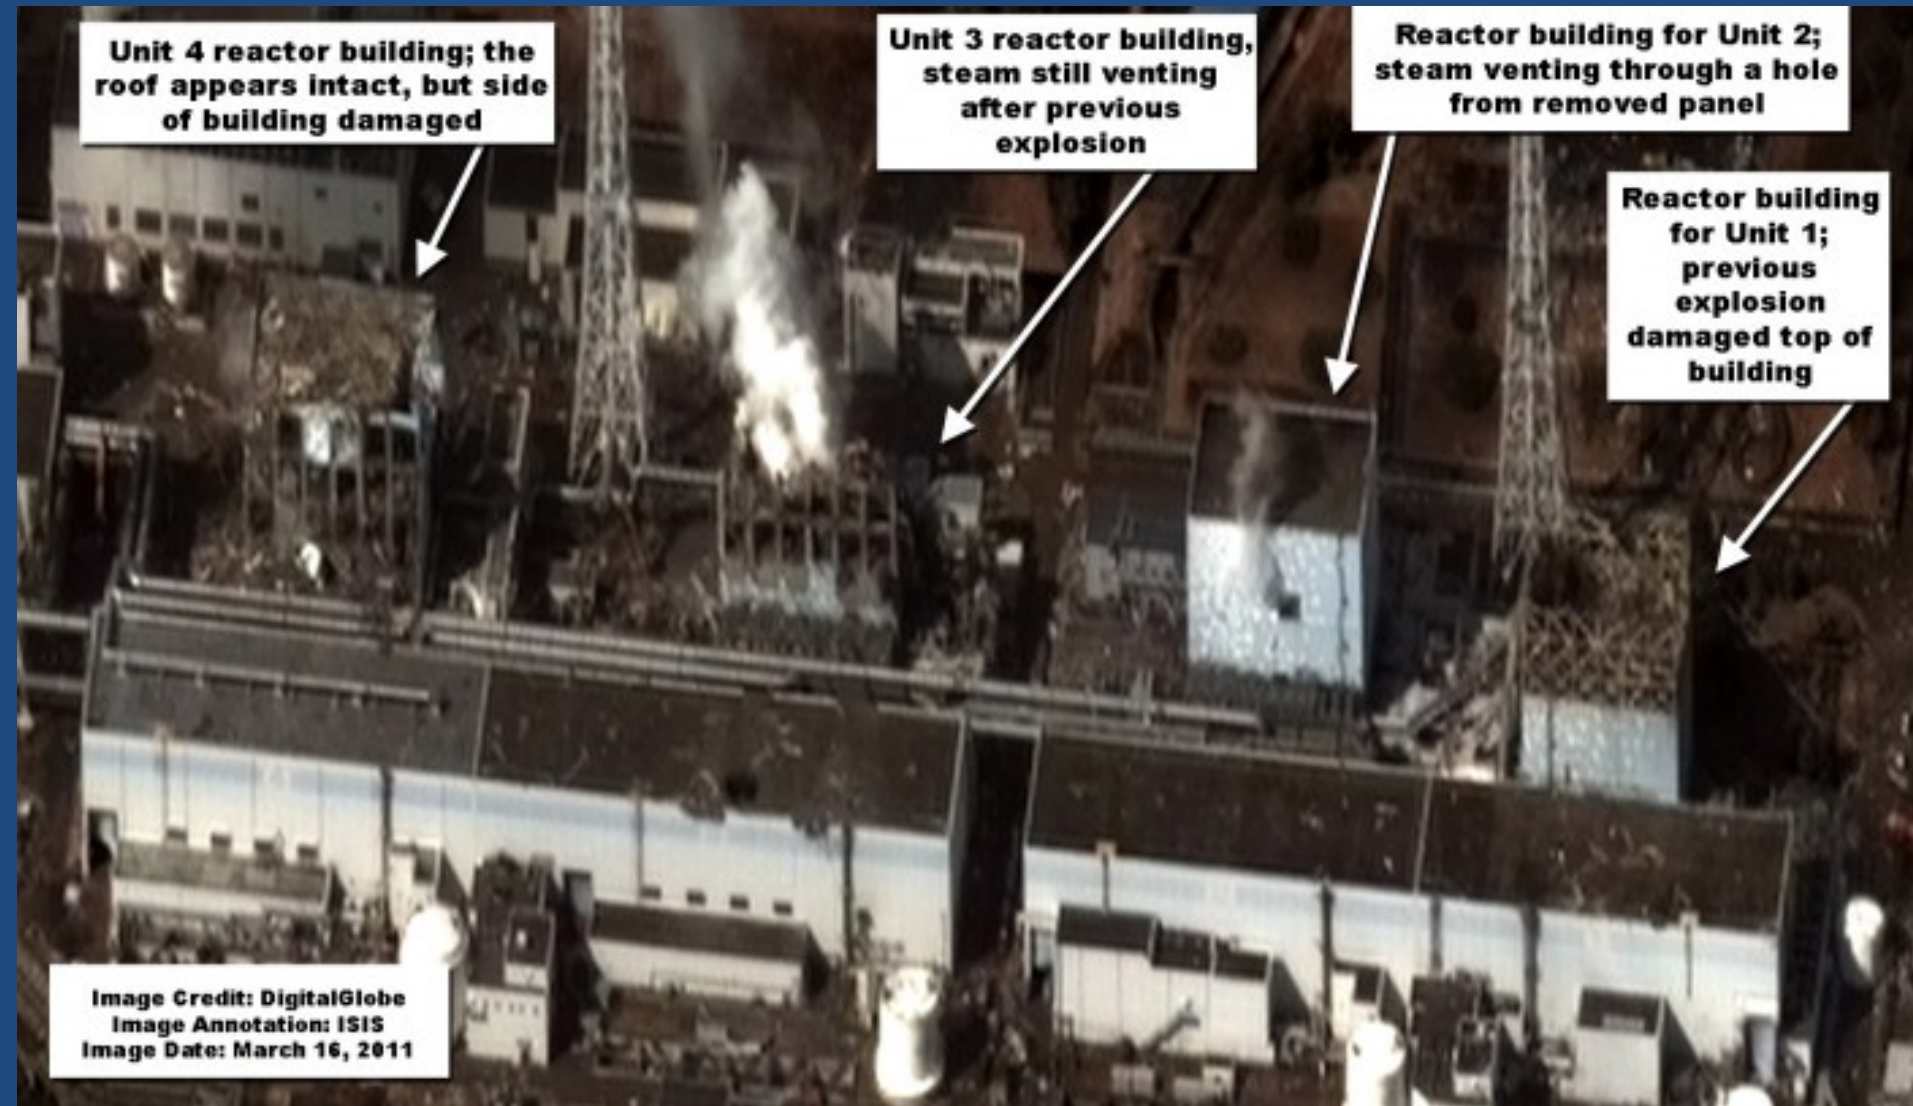
**Unit 4 reactor building; the roof appears intact, but side of building damaged**

**Unit 3 reactor building, steam still venting after previous explosion**

**Reactor building for Unit 2; steam venting through a hole from removed panel**

**Reactor building for Unit 1; previous explosion damaged top of building**

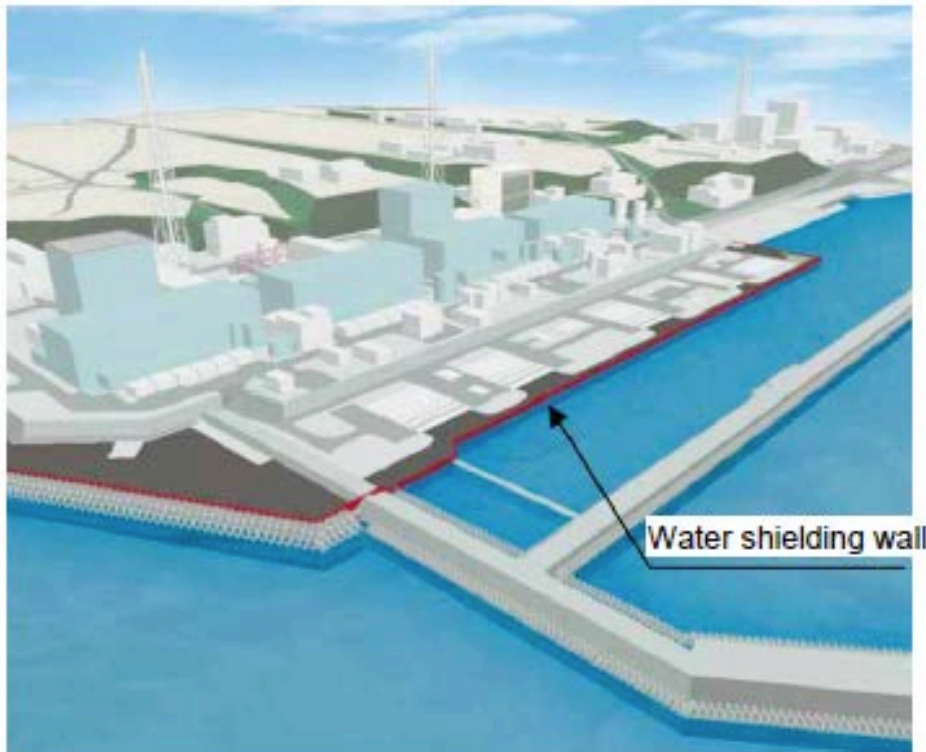
Overview

## Image of water shielding wall
