THE NUCLEAR NEWS INTERVIEW

Hart and McCollum: An overhead job at Oconee

Oconee-3's containment painting project

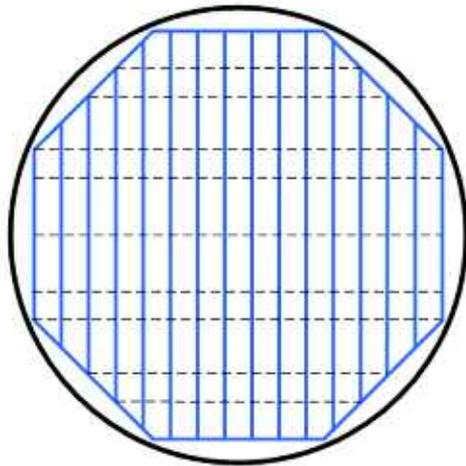
ONS Unit 3 Containment Bldg. Plan View
(Showing Spray Steel Framework Only)

Illustrations showing the spray header steel grid (left) and a cross-sectional elevation view inside containment at Oconee

Hart: We built a scaffold up there. The key, I think, was taking advantage of the spray header steel up in the dome area and working off of that. The spray header steel is a gridwork of 8-inch steel I-beams located at the area where the dome caps off the top of the wall of the containment building. Seven-eighths-inch-diameter steel sag rods that go all the way up to the ceiling of the dome support this entire grid. The reason the grid is there is to support the 6-inch-diameter stainless steel piping right below it. That piping is the building's spray system, and every so often there are spray heads on the piping. If we had an emergency situation in containment and the building pressure was going toward 60 psi, we could pump cool, borated water up to the piping and the water would spray down through the containment building, which would condense the steam cloud and drastically lower the pressure in the building. The spray system is a key component of the emergency core cooling system.

Hart: That's right. We had no floor up there to build a scaffold on, so all of the design that we did was centered on the spray header steel. That was the only thing like a floor that we had to build on. Basically, when we started to design the scaffold, we took into account that we had an I-beam every 7 feet running the width of containment, supported by X number of sag rods, each of which can carry Y amount of weight. We divided it out and calculated that in no place in this design could the scaffold weigh more than Z pounds per square foot. One of the big constraints in designing the scaffold was not only developing a design that could be affixed up there, but it had to be light enough not to exceed the allowable loading. We could have built a gargantuan structure, but we couldn't guarantee that the sag rods would hold it up.

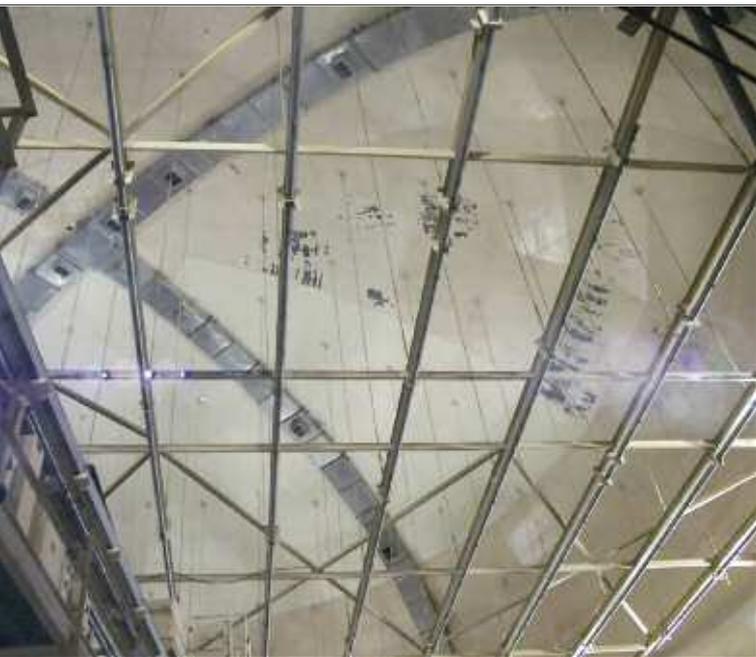
Top: This view, inside Unit 3's containment building, is looking up through the grid formed by the spray header steel. The dome shows some areas of failed coatings. (Photos: Bill Meldrum/Oconee)

The recoating project was necessary because the existing coating system—made up of 35-year-old primer and paint—was failing. Paint chips were flaking off the liner plates, causing some plant operability concerns.

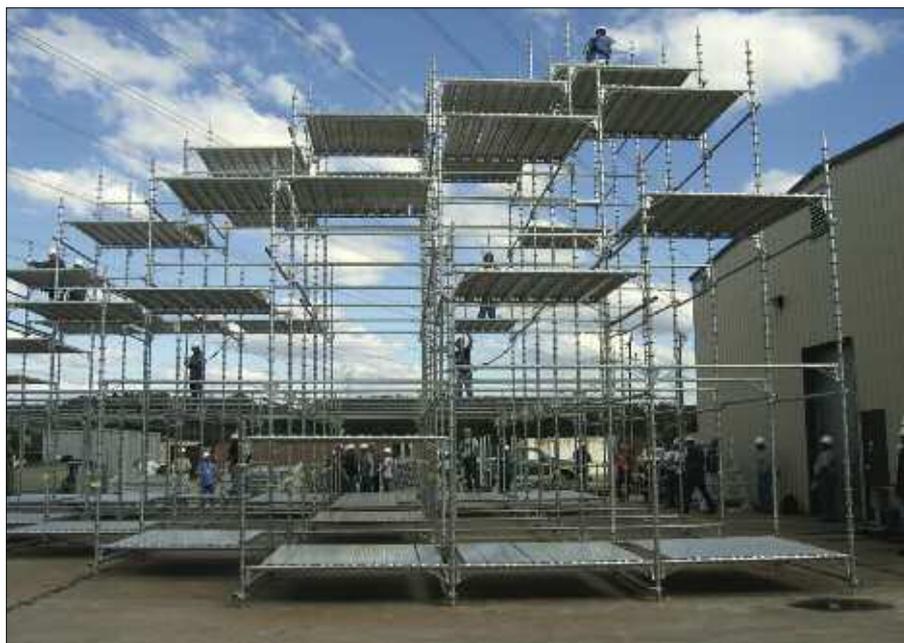
Right, top: Workers construct a scaffold mockup on the grounds of the Oconee plant. Although difficult to see, an exact layout of the spray header steel grid and the liner plate perimeter was painted on the concrete slab supporting the scaffold. The mockup represented about half of what was actually built in containment.

McCullum: Yes, we did. That, along with providing practice for the scaffold builders, was one of the main reasons we did a full-scale mockup exercise using the actual scaffold components out in the parking lot, prior to the actual work in containment. Also, in addition to the scaffold mockup, we used a small mockup of the liner plates so that the coating technicians could practice using the abatement tools.

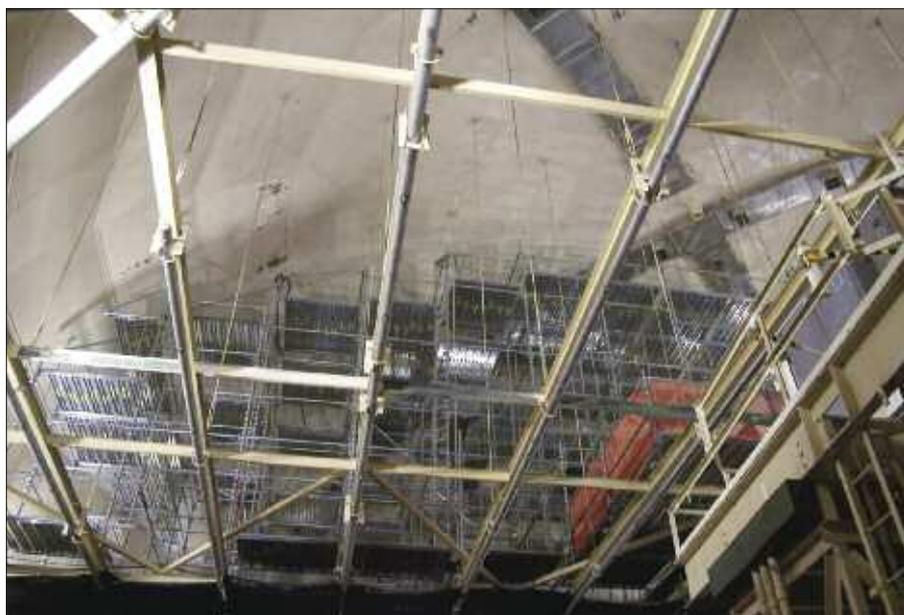
Right, bottom: Scaffolding was erected on top of the spray header steel.

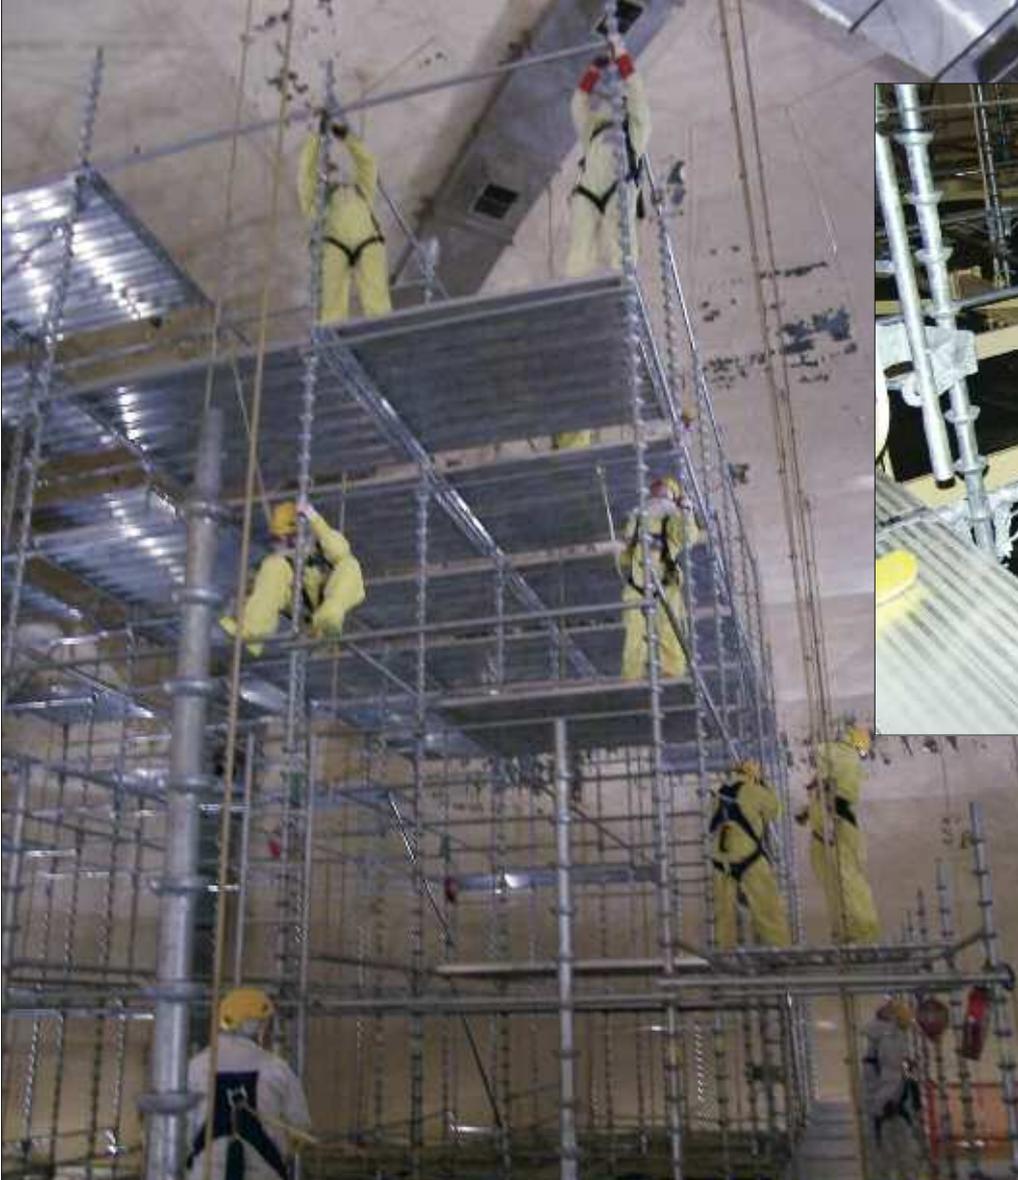
Top, right: The scaffolding was attached to the spray header steel by using a customized foot fabricated by Excel Scaffolding.
