THE NUCLEAR NEWS INTERVIEW

## Rick Libra: A safe and successful outage

*About 2.5 million person-hours were worked during TMI-1's recent outage, with no lost-time injuries.*

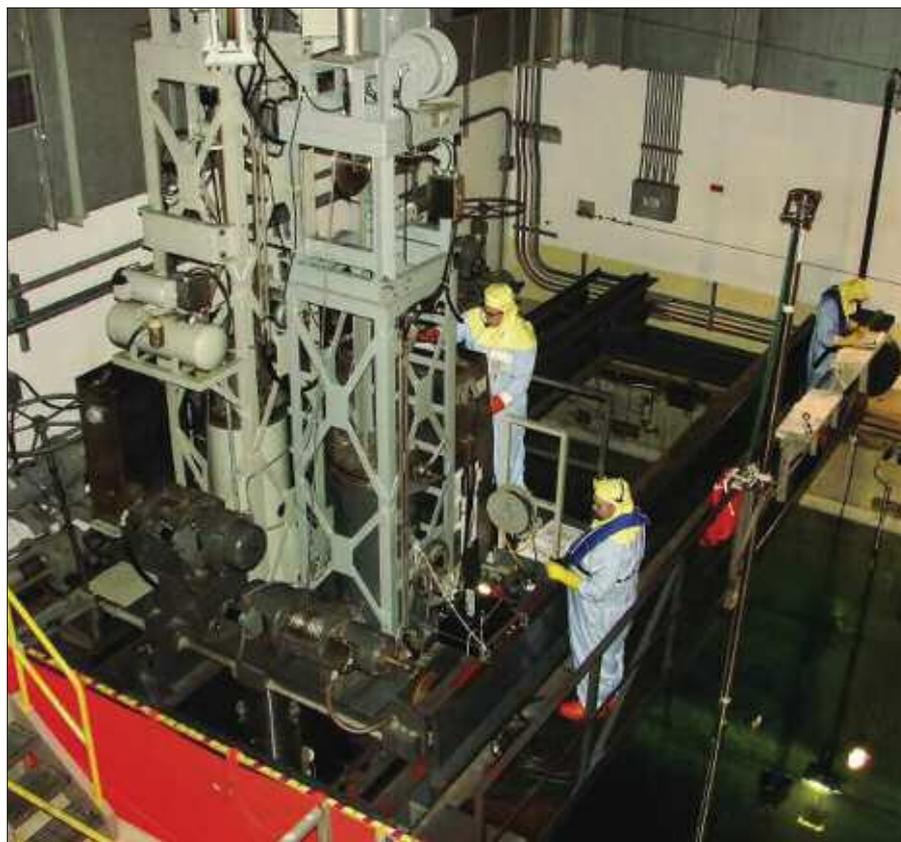
TMI personnel refuel the reactor. (Photos: Exelon Nuclear)

We also had no plant restart issues following the outage. We had flawless performance from our operators and reactor services people in doing more than 1000 fuel assembly moves. That included defueling the reactor to our fuel pool and then refueling it after all the work was done, including changing the design of the fuel assemblies. All this work was done without a single human performance issue.

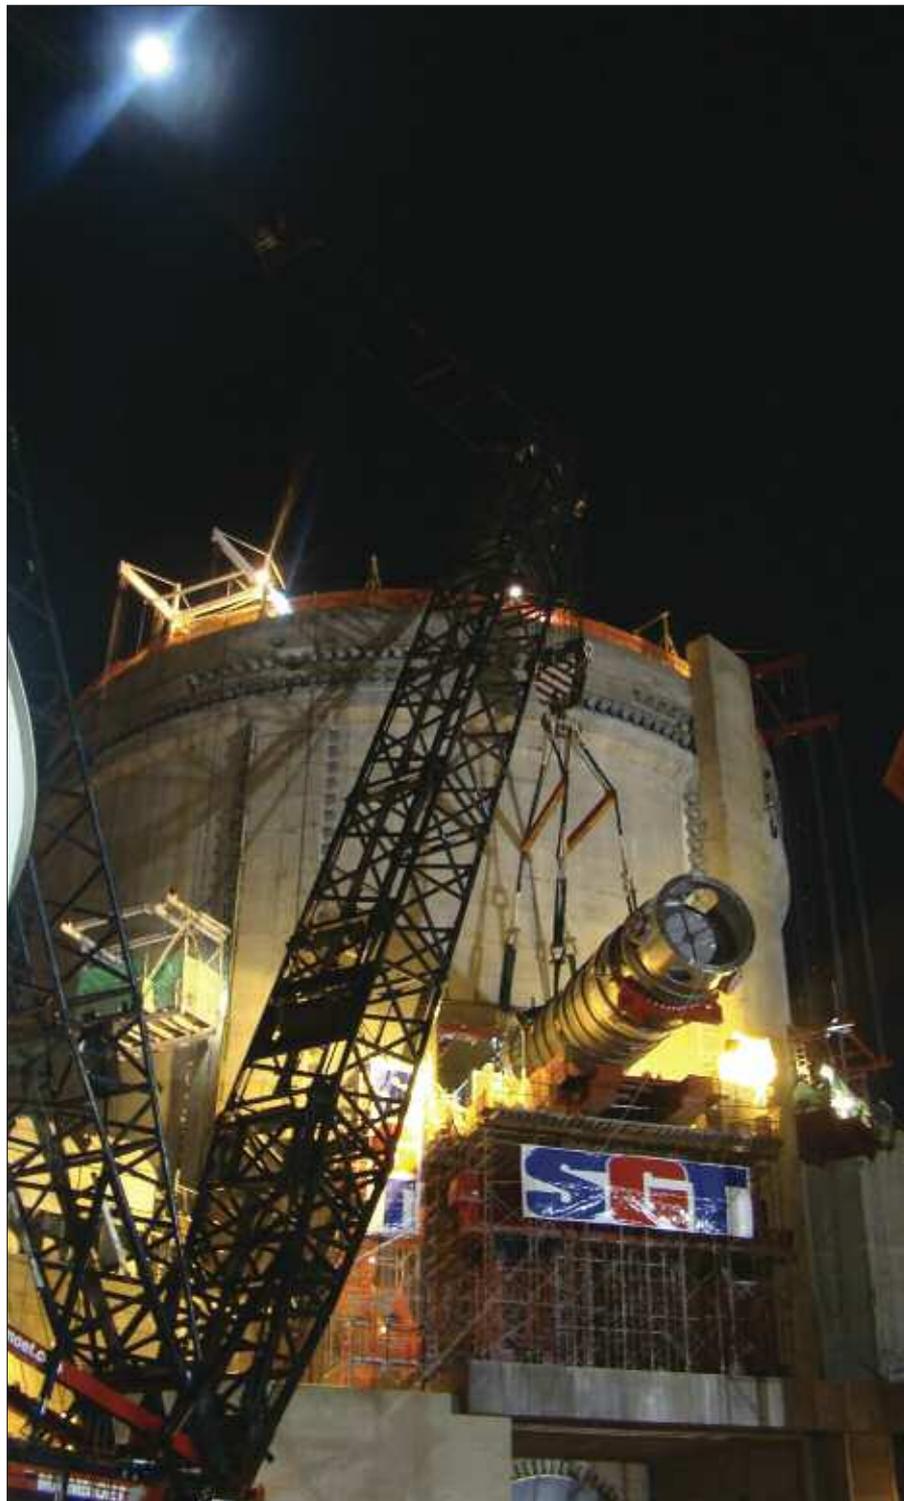
Under a full moon, a new steam generator is moved inside of the reactor building.

We had to cut a 23 ft × 26 ft rectangle in the side of our containment in order to move the steam generators in and out. We took out the cement to a depth of 3 feet and a few inches of steel rebar, and then cut through the steel liner. After we were done, we moved the old steam generators out of the building and moved the new ones in. We also had to install totally new cranes and

heavy-lifting equipment with platforms to get the steam generators in and out. It was a real engineering feat, and SGT and the project team did a great job. It's probably the only time in my career that I'll see something moved quite like that.

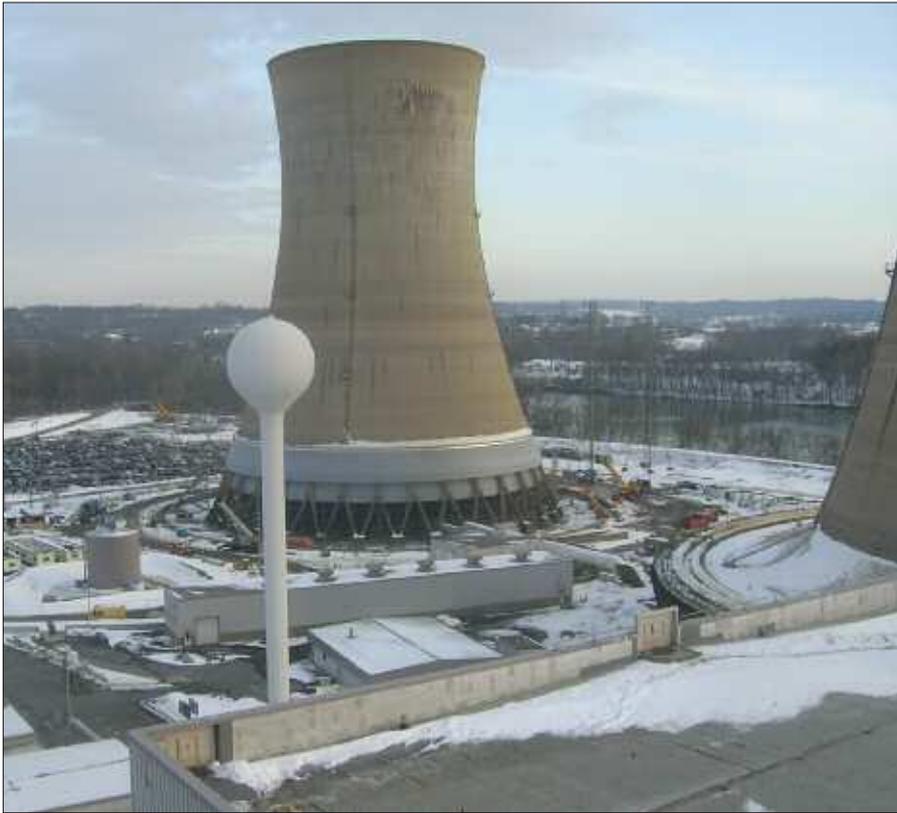
The drift eliminator on TMI-I's "A" cooling tower, which extended out about 30 feet all the way around the base of the tower, was removed during the outage. The plant's "B" cooling tower, of which part of the base can be seen at right in the photo, still has its drift eliminator in place.

There are two types of cooling towers—cross-flow and counterflow. After this outage, we now have one of each. The “A” cooling tower was converted from a cross-flow to a counterflow. The tower's exterior wood structure, which consisted of a drift eliminator—*asbestos fill and spill ponds*—is gone.

Both of our hyperbolic cooling towers are still here, but if you look at the base of one of them, you'll see that it extends out about 30 feet or so all the way around the entire circumference. That is the drift eliminator, and it looks like the head of an inverted pin. But the “A” cooling tower no longer has that because of the work we did during the outage. We removed the drift eliminator section altogether. And the fill of the cooling tower is all internal, making it a counterflow cooling tower now. It's much more efficient. We're going to get about 3 more megawatts in the summer from that design change.

Also, there's no wood to decay over time inside the cooling tower because the wood has been replaced by a fiberglass-composite-type material that requires less maintenance, is much more efficient, and sets us up for the lifetime of the plant. The new material, which is much more environmentally friendly, replaced 550 tons of nonfriable asbestos fill. It's a huge improvement for the site.
