# Nuclear News Special Report: Fukushima Daiichi after the Earthquake and Tsunami

## Natural disasters lead to nuclear emergency at Japan's Fukushima Daiichi

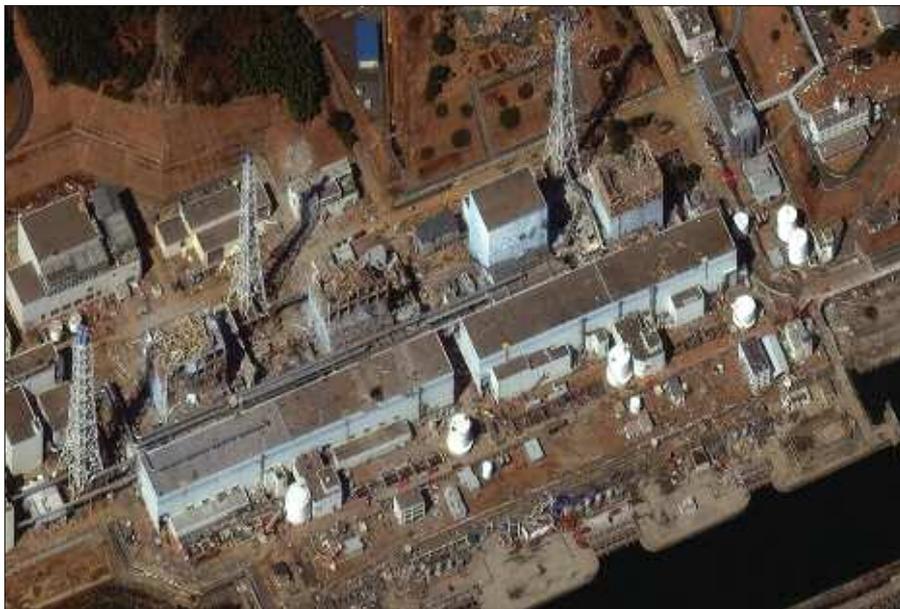
This satellite image, released by DigitalGlobe on March 18, shows the substantial damage to the external structures of the reactor buildings of (from left) Units 4, 3, 2, and 1 of the Fukushima Daiichi plant. The hydrogen explosions that caused the damage occurred outside of the reactor containments. (Photo: Reuters/DigitalGlobe/Handout)

At 3:36 p.m. on March 12, a hydrogen explosion occurred at the top of the Unit 1 reactor building, blowing out a large section of the roof and the walls of the top floor. Four Tepco technicians were injured and hospitalized. At the time, the explosion did not appear to damage the reactor pressure vessel or primary containment vessel. As radiation levels also increased substantially, it became clear that there was fuel damage and possibly some melting. Later that day, the evacuation zone was enlarged to a 20-km (12-mi.) radius.

the water level soon dropped again, and some core melting occurred. Then, at 11:01 a.m. on March 14, a hydrogen explosion occurred in the upper part of the Unit 3 reactor building, blowing out large sections of walls and injuring 11 people.

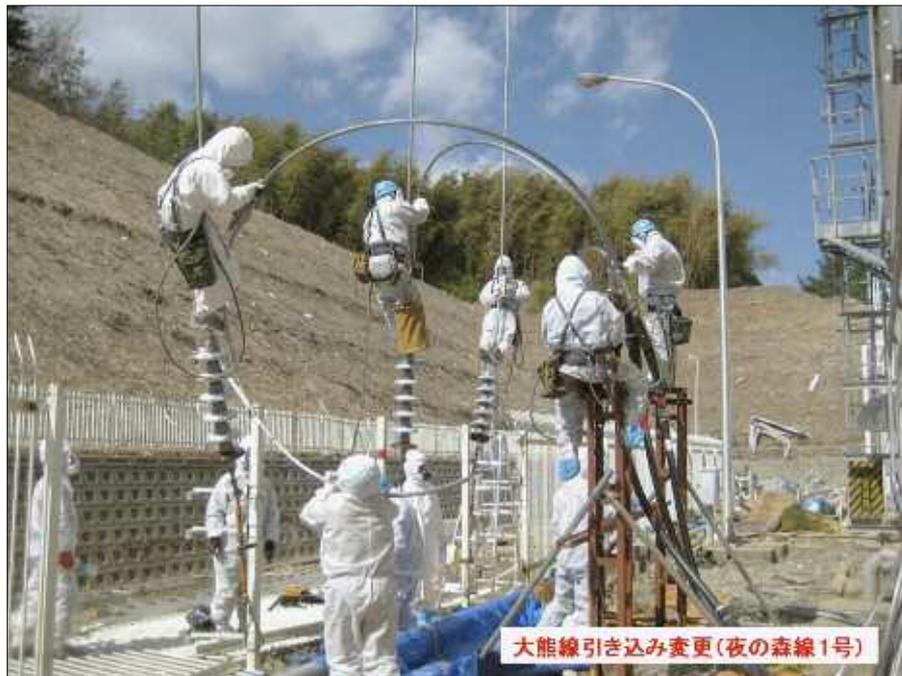
On March 18, workers repair equipment in an effort to restore off-site power to Units 3 and 4 at Fukushima Daiichi. (Photo: Tokyo Electric Power Company/Kyodo via AP Images)

Work to reconnect the units to an off-site transmission line moved forward slowly. Power for Units 5 and 6, which achieved cold shutdown on March 20, switched from emergency diesel generators to an off-site power source on March 22. For the damaged Units 1–4, however, power reconnection was a slow process. Several systems required a great deal of repair work before it was possible to connect the units and pow-

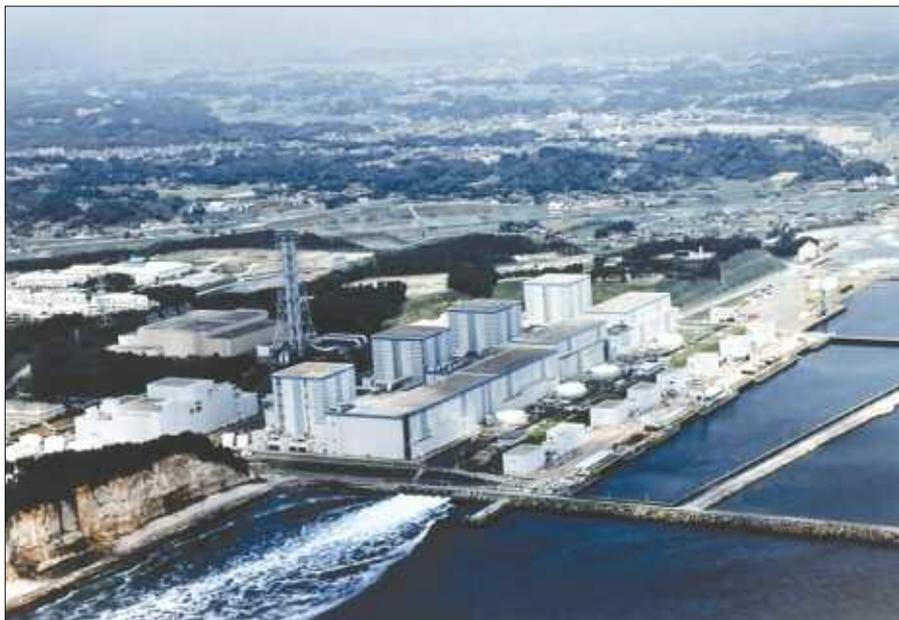
Brief pressure control issues arose at Fukushima Daini-1 and -2, but by the morning of March 15, all four reactors at the site had been taken to cold shutdown. (Photo: Tepco)

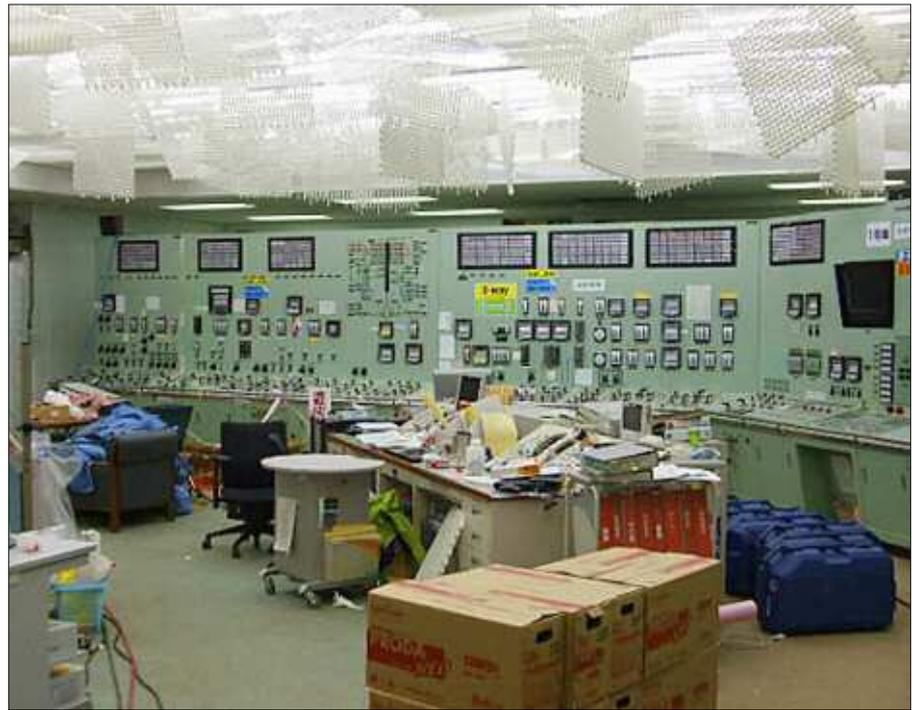
The Unit 1 control room on March 24, after lighting was restored. (Photo: Tokyo Electric Power Company/Kyodo via AP Images)
