Zion: A Progress Report

With the spent fuel removed to an ISFSI and the large components removed, crews are ramping up demolition work at the Zion plant.

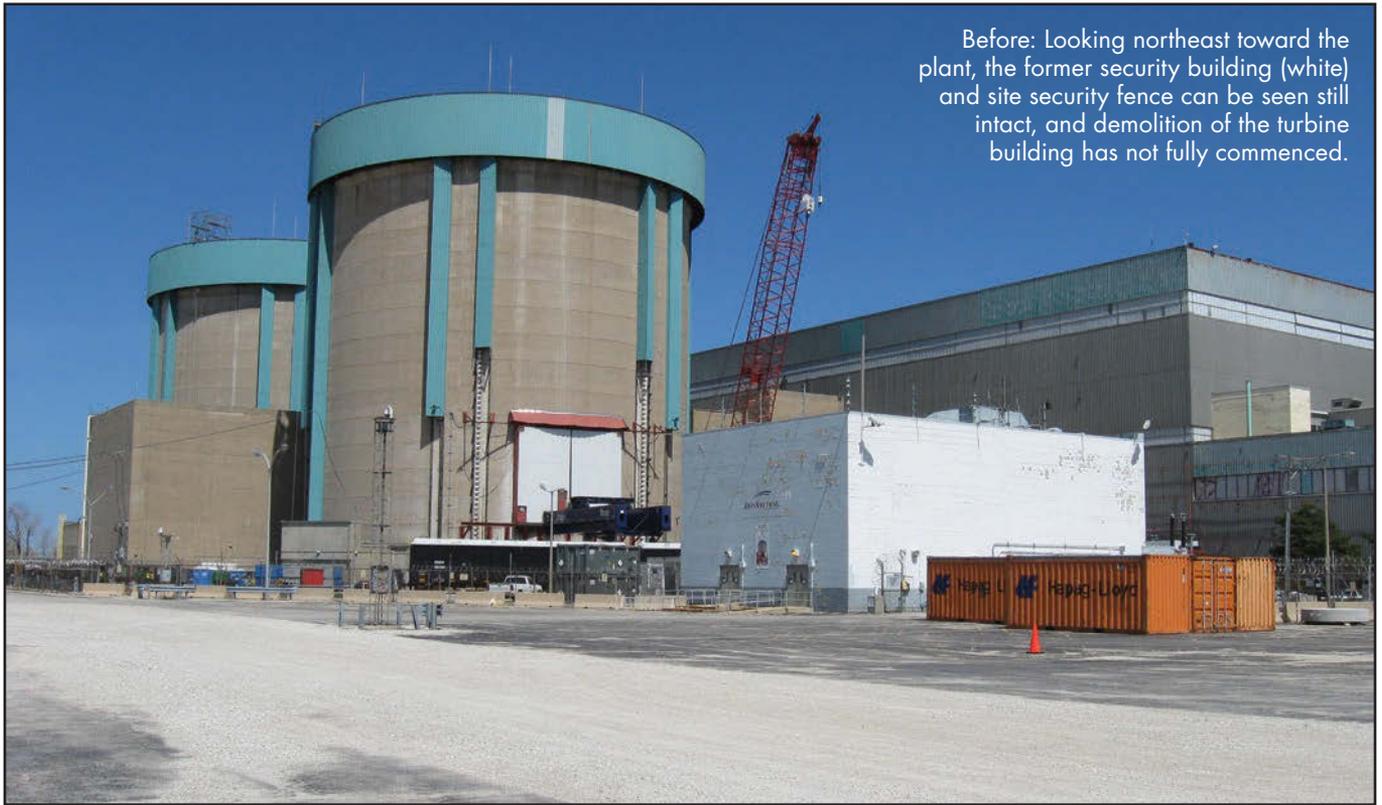
Before: Looking northeast toward the plant, the former security building (white) and site security fence can be seen still intact, and demolition of the turbine building has not fully commenced.

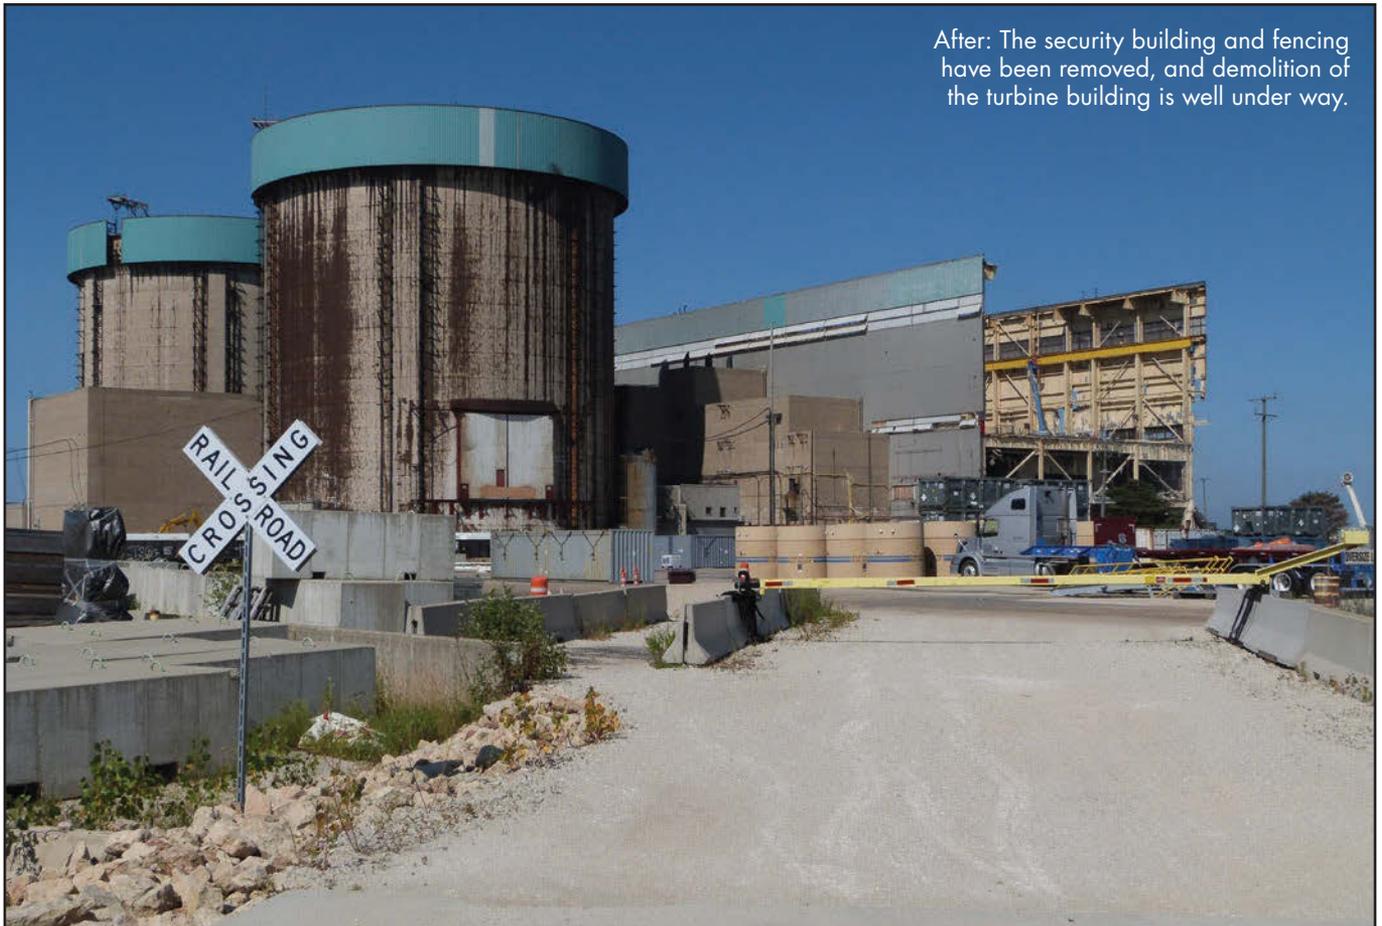
After: The security building and fencing have been removed, and demolition of the turbine building is well under way.

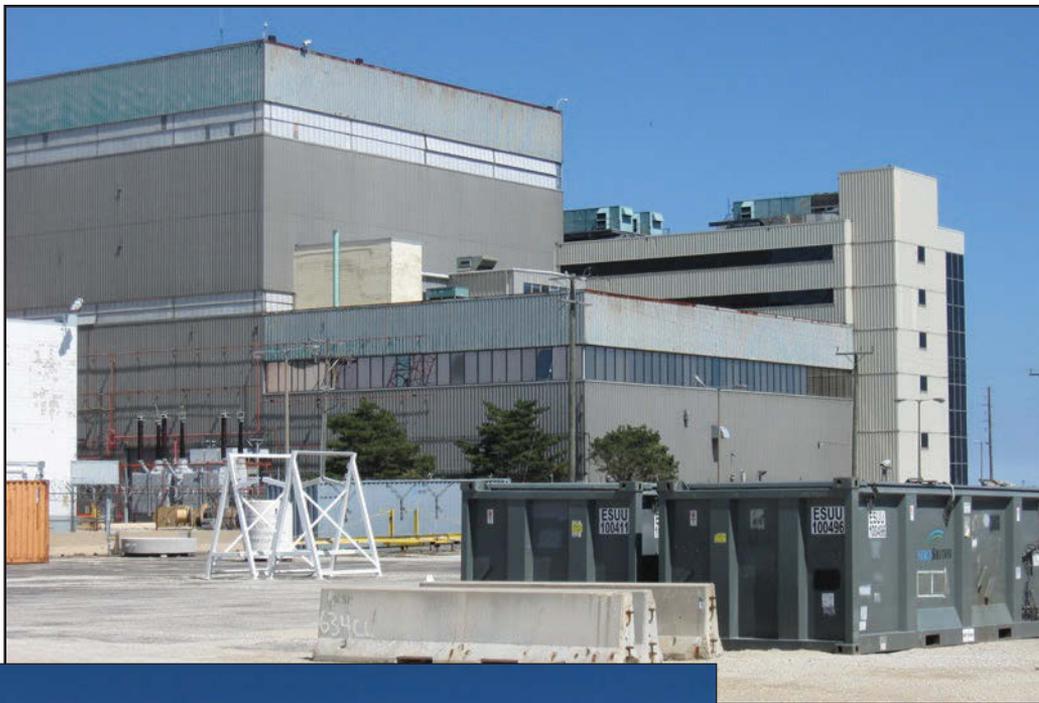
▲ Before: Zion's administrative and office service buildings flank the south end of the turbine building.

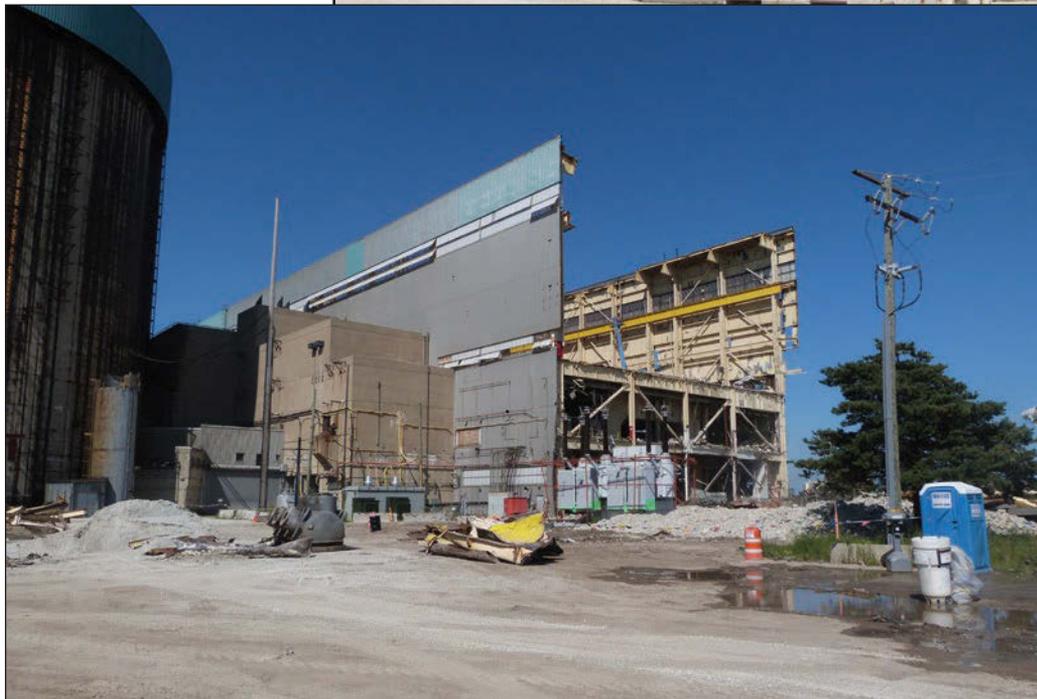
◀ After: The service buildings have been removed and backfilled. Demolition of the turbine building is scheduled to be completed by February 2017.

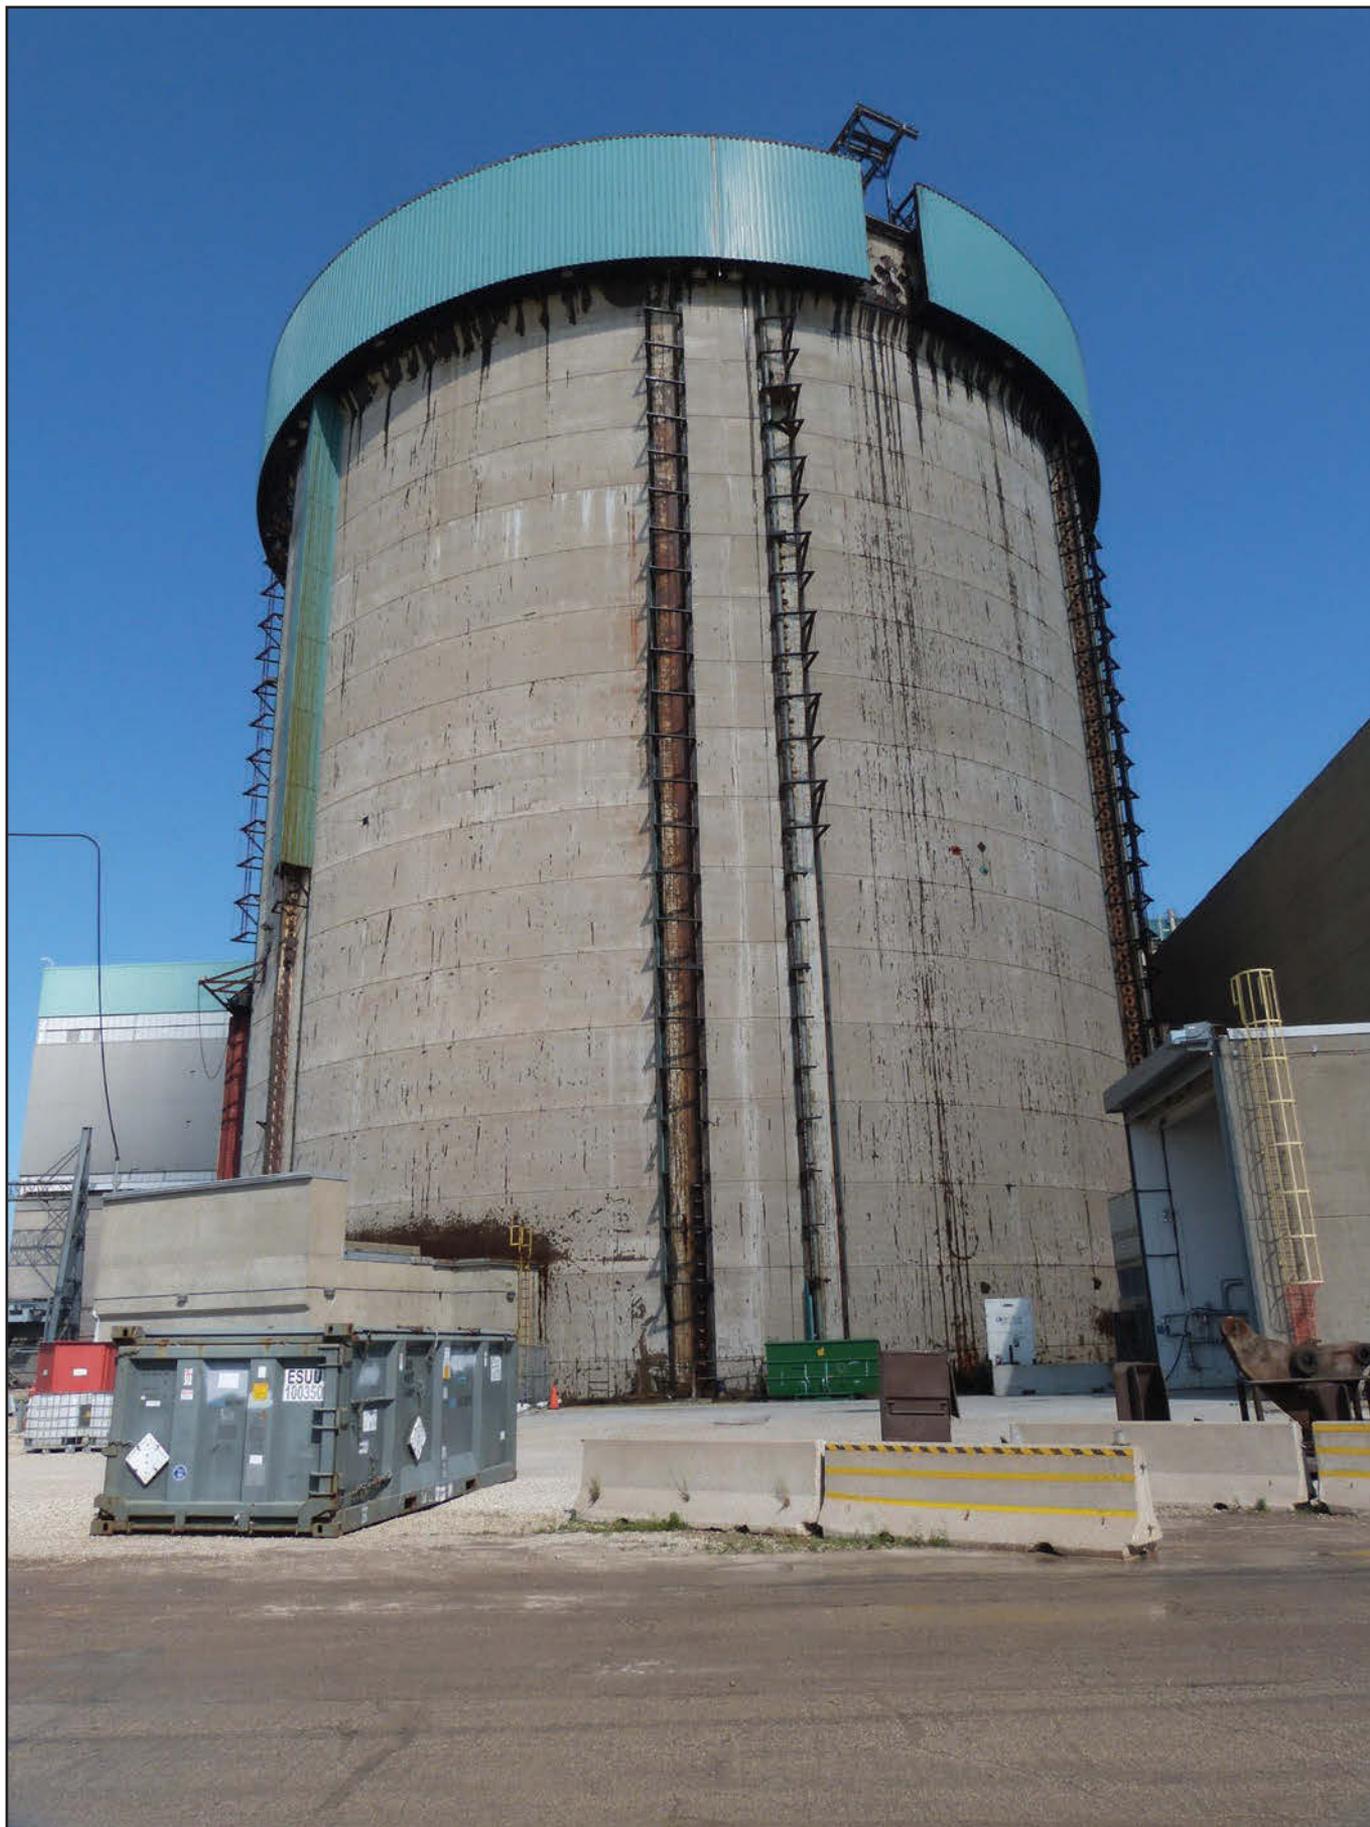
Detensioning and removal of the tendons from Zion's Unit 1 and 2 containment buildings was completed in June. The tendons provided structural reinforcement to the buildings so that they could withstand severe earthquakes. The ventilated interior demolition of the containment buildings is planned to begin in October of this year.

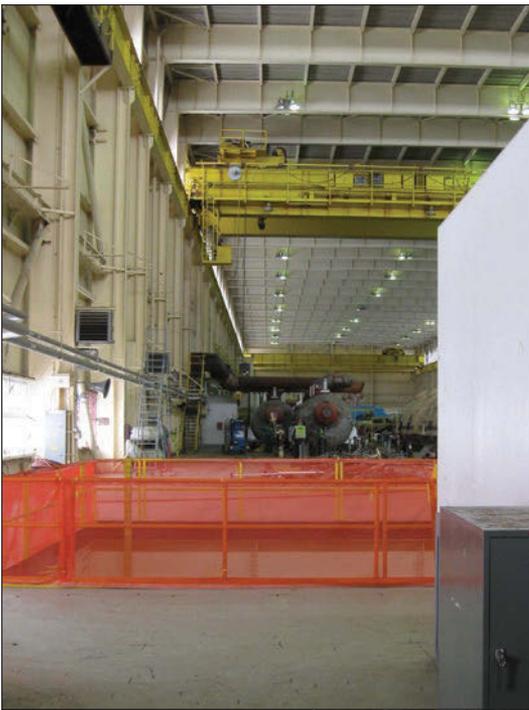
◀ Before: Inside the turbine building, the interior is still largely intact, with heavy components still remaining to be removed.

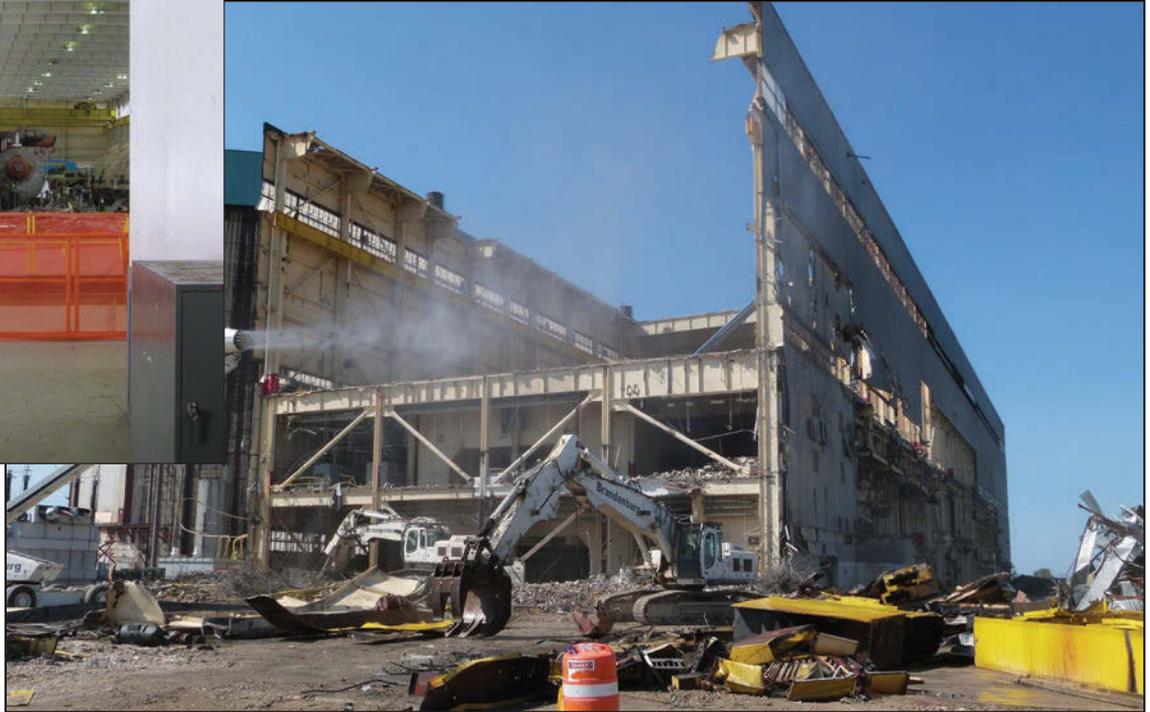
▼ After: The building's roof and south wall have been removed as workers remove the structure from the top down. Metal from the building and components is separated for recycling.

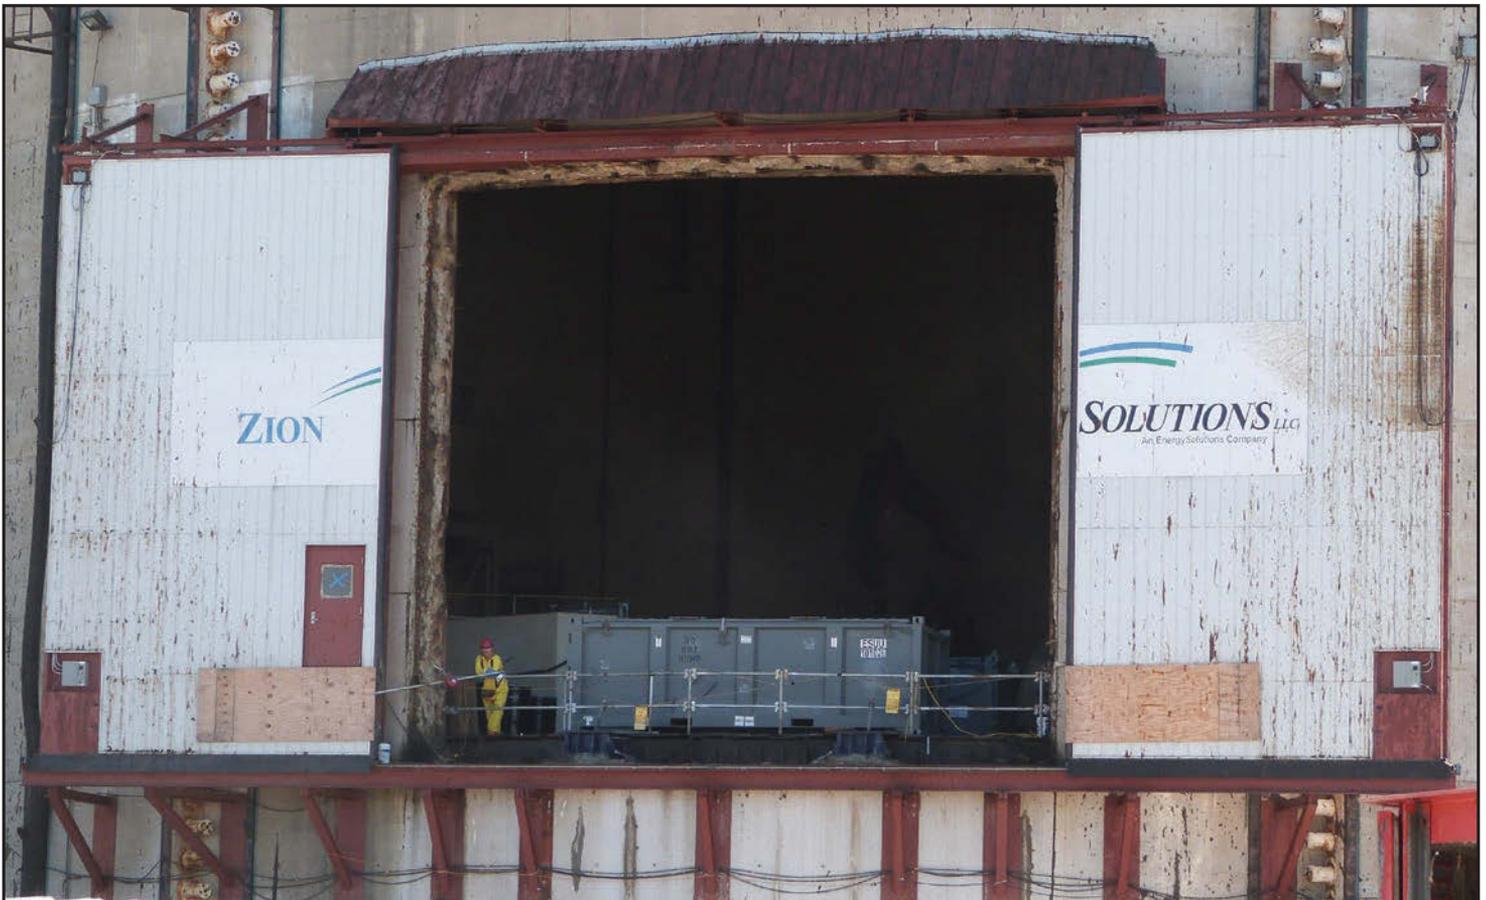
A worker stands in a doorway cut into Zion's Unit 1 containment building in July. ZionSolutions says it is on track to complete decommissioning by 2018.
