## Davis-Besse's 20th outage: The "Drive For 25"

*As a result of detailed planning, improved communications, and a united effort, Davis-Besse and its contractors achieved their 25-day outage goal—a plant record.*

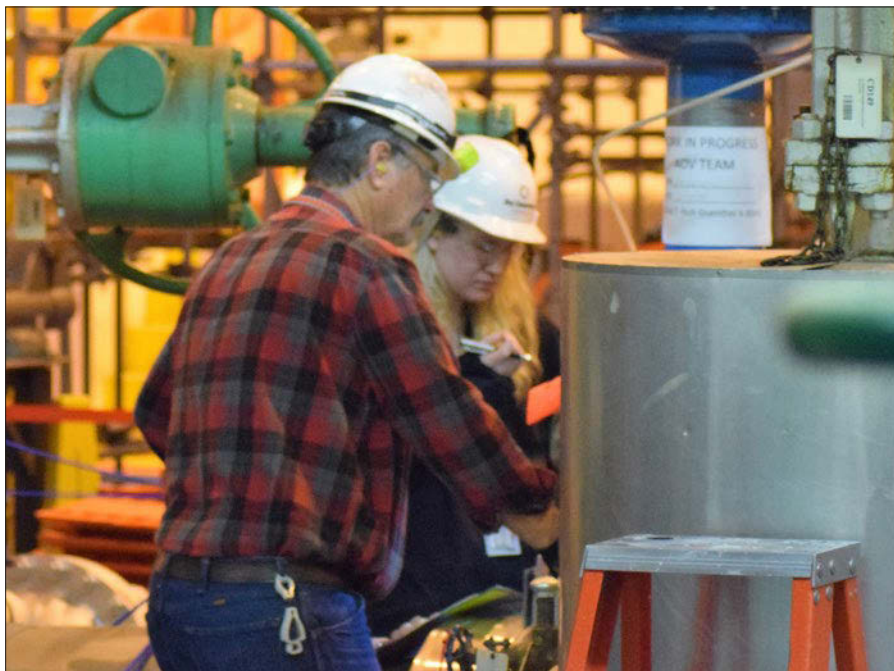
Members of the air-operated valve (AOV) maintenance team conduct work on a valve on the turbine deck. The AOV team conducted overhauls, calibrations, packing consolidations and adjustments, and diagnostic testing on 39 different valves during the outage.

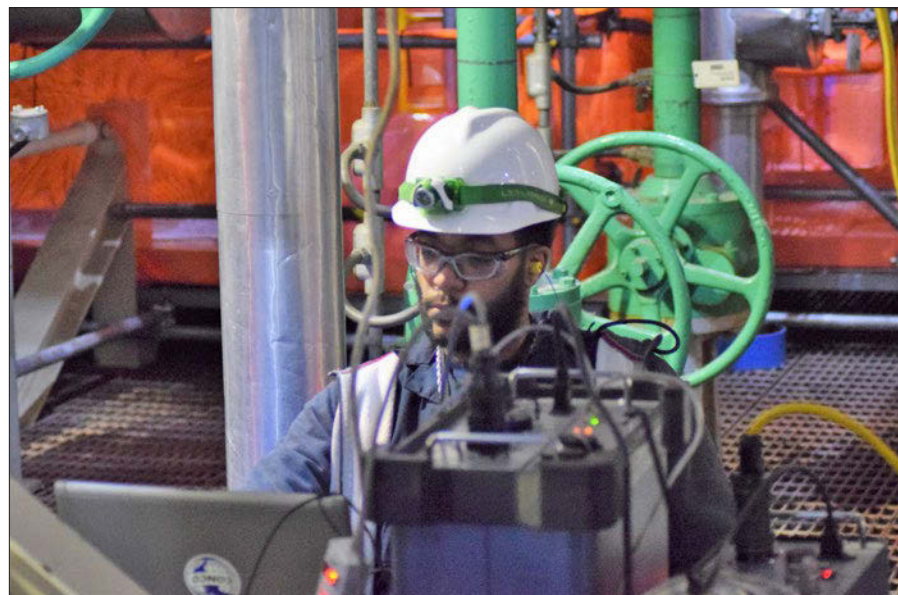
A Conco employee conducts feedwater eddy current testing during the outage.

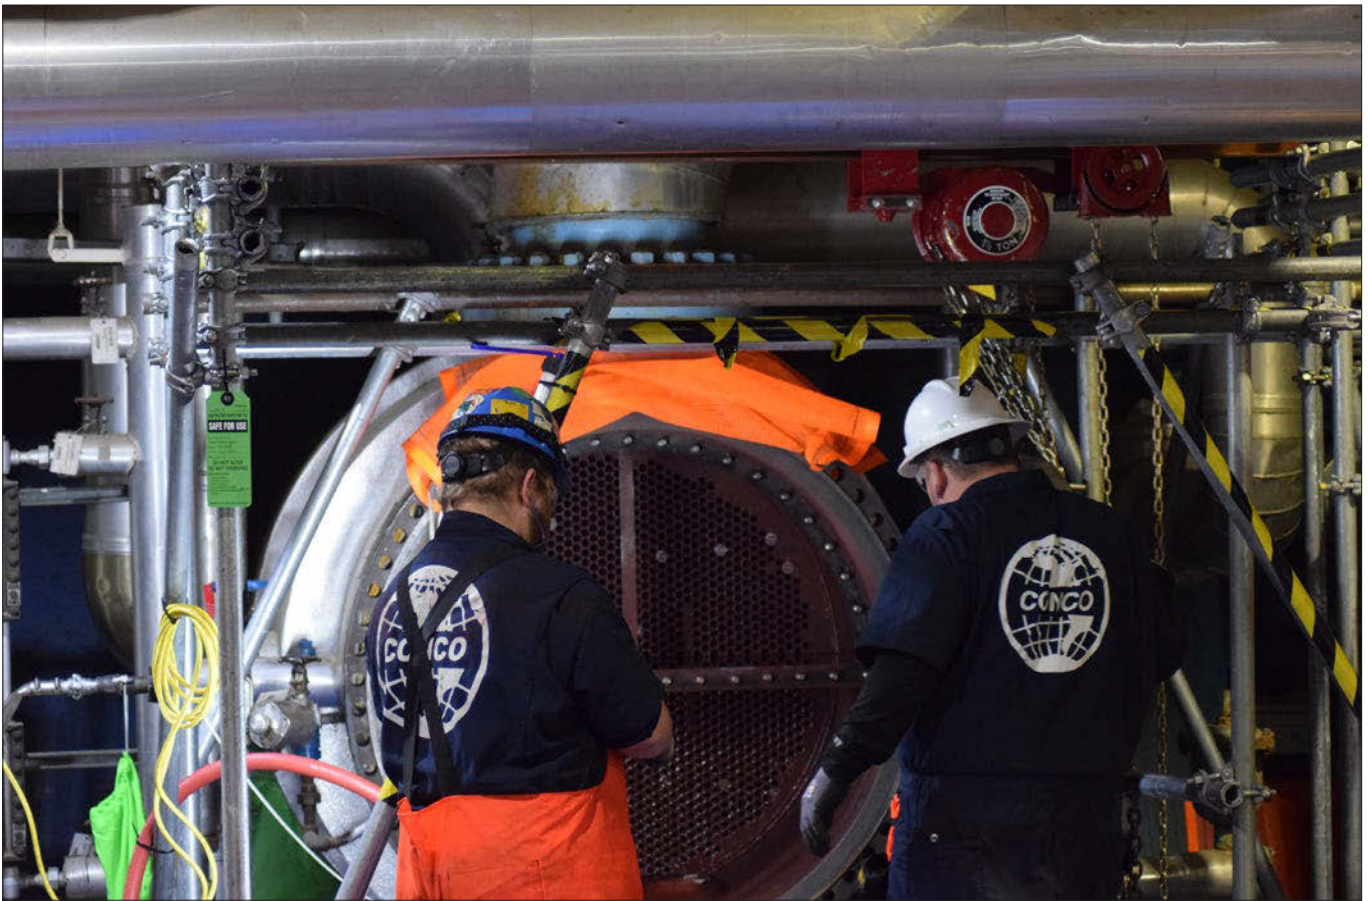
Workers prepare to reinstall the cover on one of the plant feedwater heaters during the outage.

■ Work scheduled on a low-pressure feedwater heater was not only planned to bring this piece of equipment back to life, but also to restore plant efficiency. A water leak in the heater had caused plant operators to bypass it, resulting in a 7-MW production loss during the operating cycle.

"In the past, we would just plug tubes that were leaking," said Project Manager Mark Wymer. "If it got too bad, we'd have to re-tube the entire heater, and that's a big deal."

A new process brought to Davis-Besse by Framatome (formerly Areva) had technicians identify problem tubes through eddy current testing and then insert sleeves in them. "The sleeves are then expanded for a tight fit," Wymer said. "These eliminate tube flaws and extend the life of the feedwater heaters well into the future." In this effort, several tubes that had been plugged for years were recovered.

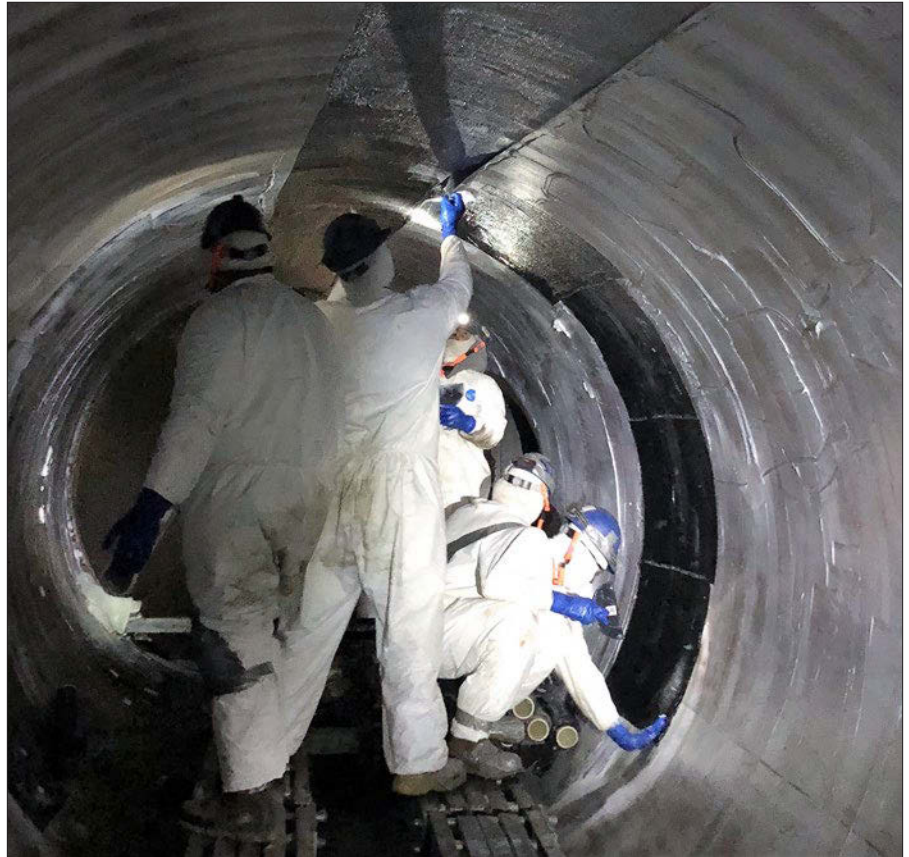
■ Davis-Besse's cooling tower suffered the effects of many brutal winters along the shores of Lake Erie. Ice had been falling from the tower and onto the circulating water piping below for four decades, and this problem needed to be corrected.

Technicians apply carbon fiber wrap to the inside of one of the two 108-inch circulating water pipes near the Davis-Besse cooling tower to help mitigate years of damage caused by falling snow and ice.

Project Manager Stevie Darr developed a two-phase plan to protect and refurbish the two concrete pipes that each carry 225,000 gallons of water from the plant to the tower every minute. The first step involved fabricating a rubber and metal

bumper to fit over pipe sections that are aboveground. The second phase had crews from Structural Technologies apply a carbon fiber wrap to the inside of the 108-inch-diameter pipes. “It’s essentially a new pipe,” Darr said.

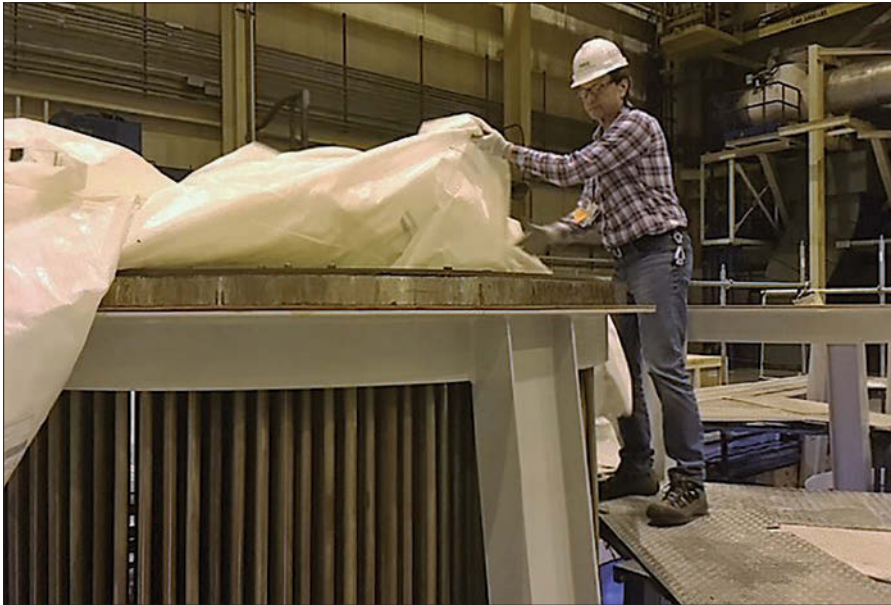
Project Manager Mark Wymer uncovers a tube bundle staged for replacement in one of the Davis-Besse condensate polishers.

■ It had been more than 15 years since Davis-Besse’s condensate polishers got the kind of attention they received during 1R20. Polishers function like a water softener to filter water and limit the wear on key pieces of plant equipment. As the outage was being planned, questions were raised as to whether work on all four polishers could fit into a 25-day schedule.

“We bought two new frames and tubed them before the outage,” Wymer said. “We removed the first two tube bundles and replaced them with the new ones.” Then, the two bundles that were removed were refurbished and put into the last two polishers. Maintaining the secondary water chemistry at optimum levels helps ensure the long-term reliability of plant components.

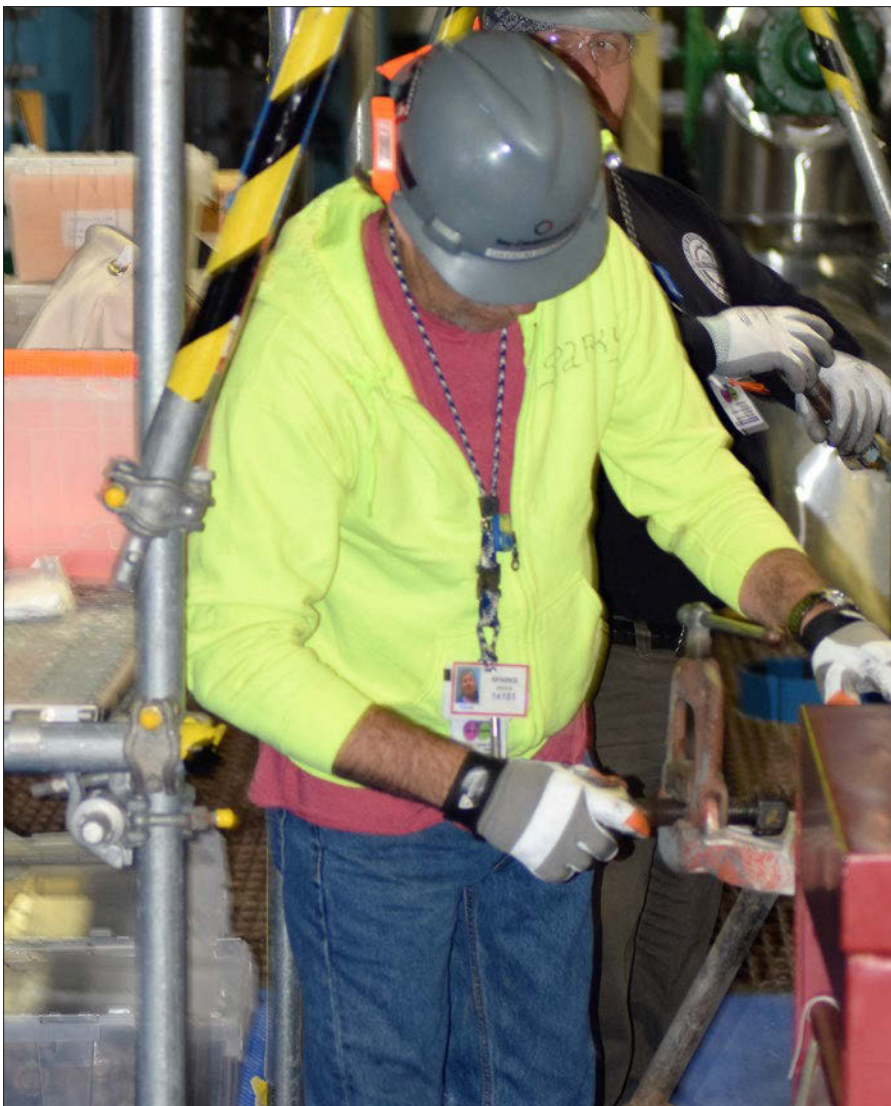
One activity not accounted for in the original outage scope was cleaning and refurbishing the bolts that hold the condensate polishers together. More than 400 bolts had to be blasted and cleaned, and any burrs or irregularities removed. Creative scheduling got this key task included in the outage work.

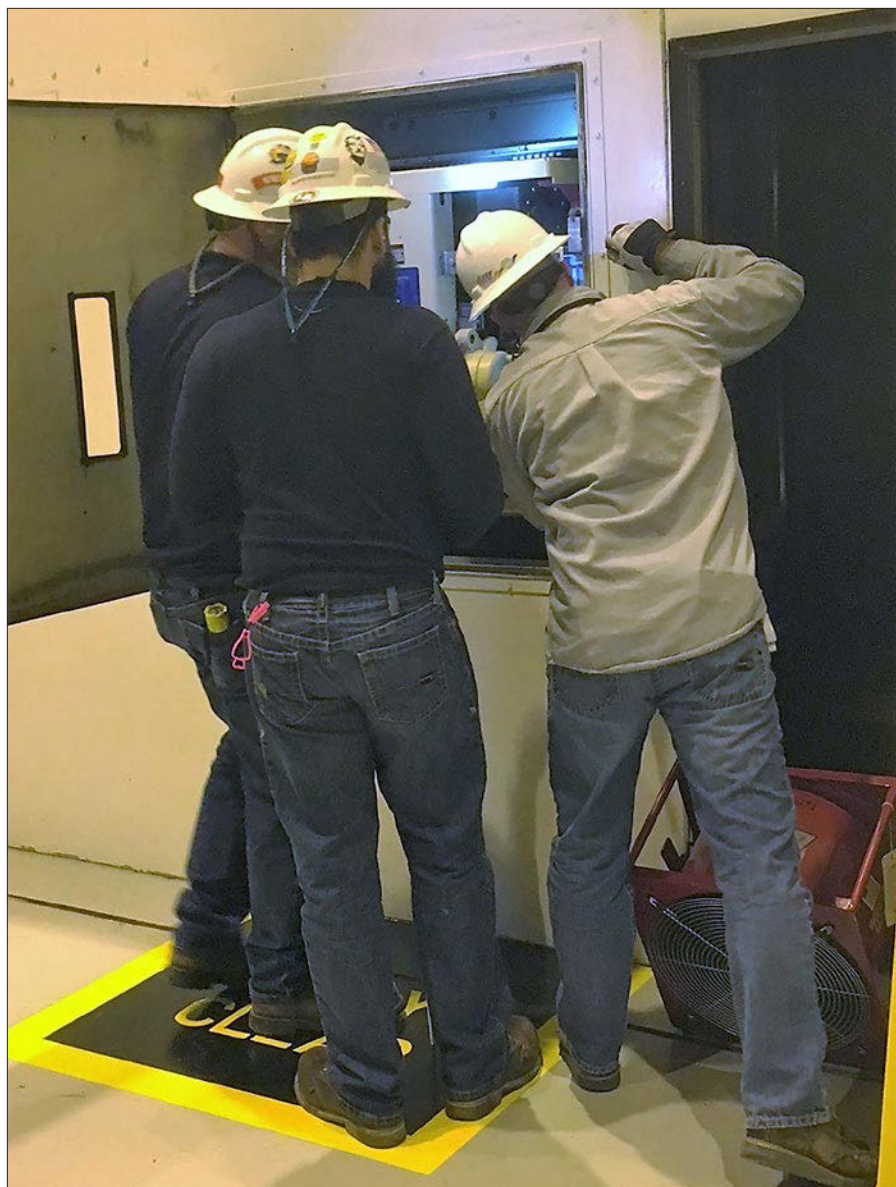
Plant electricians rack-in the exciter field breaker as Davis-Besse prepares to return to service following its IR20 outage.

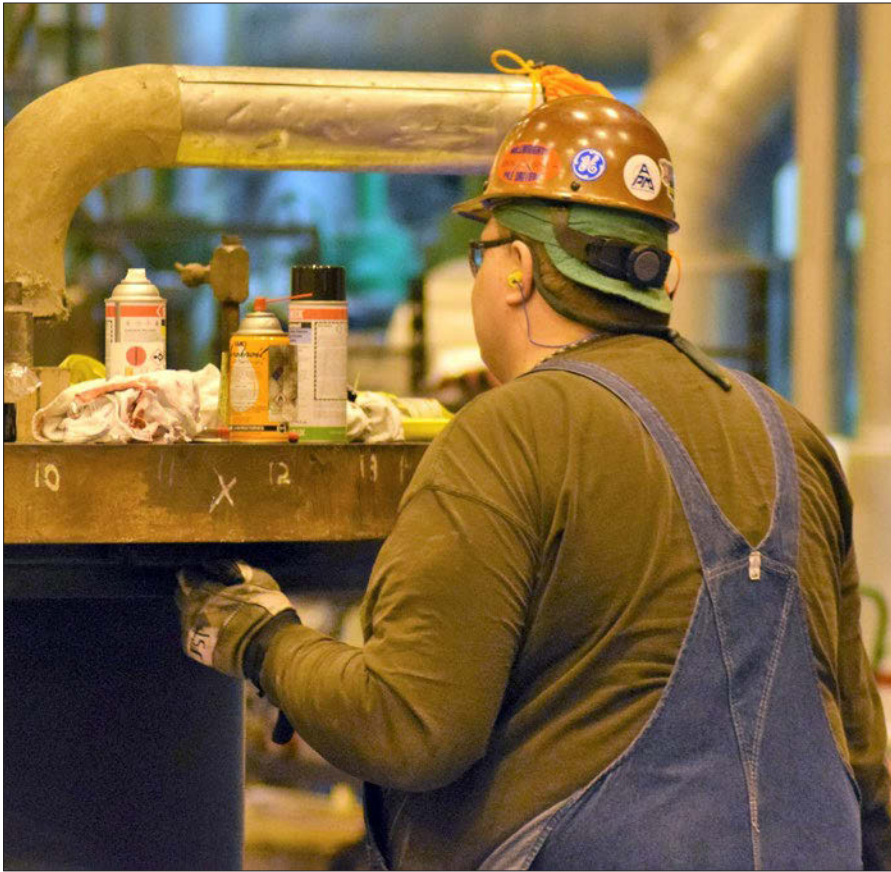
A General Electric technician cleans parts as his group begins to reassemble the Davis-Besse turbine.

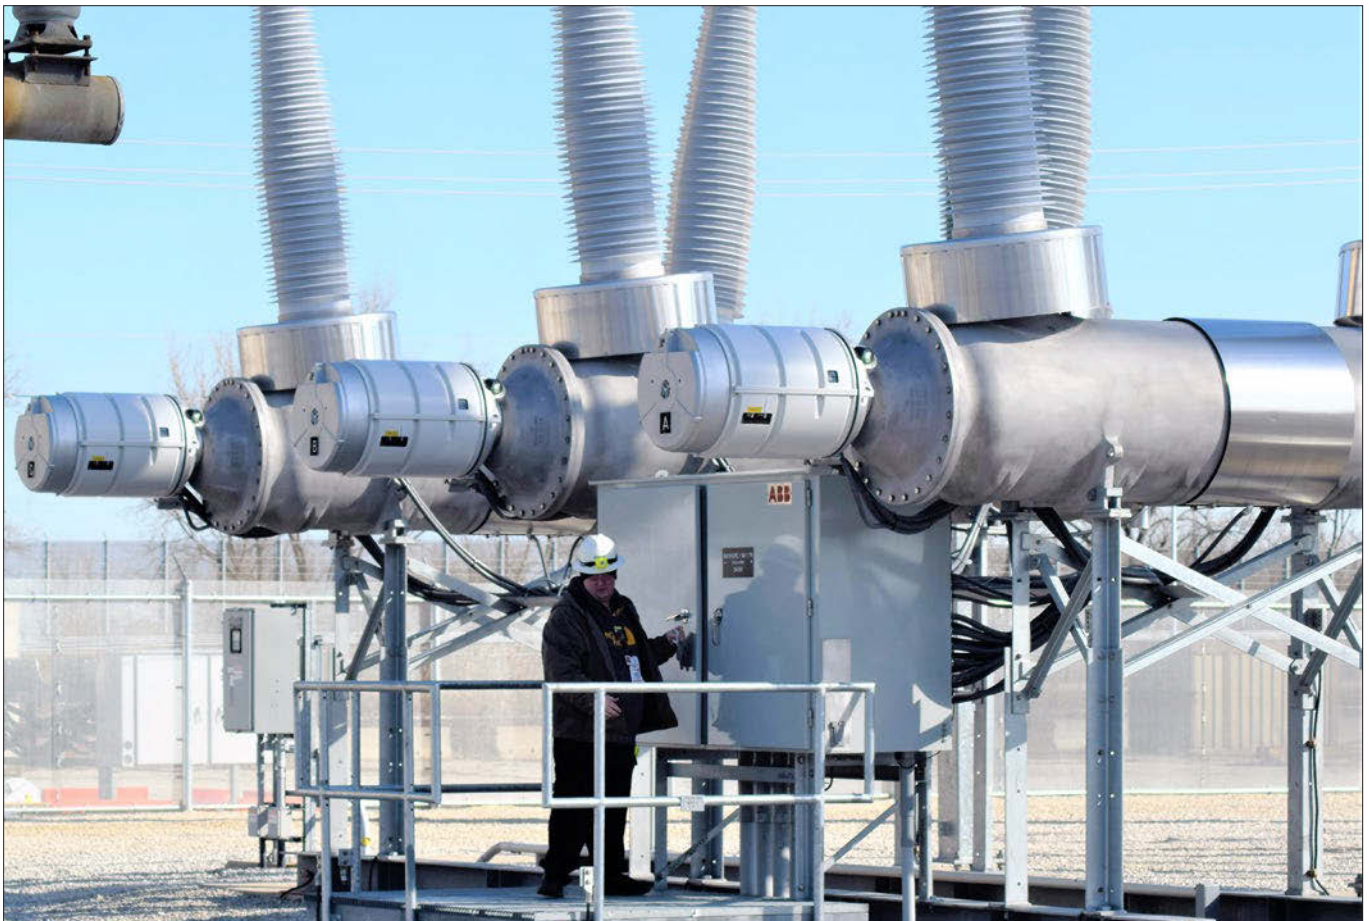
Operator Chris Simpson closes the control cabinet on the DB-34561 output breaker after switchyard work was completed.
