# An aging management program for neutron absorber materials in SFPs

*EPRI's multiyear research provides nuclear plants with an efficient aging management program that ensures criticality safety margins are maintained for spent fuel pools.*

By Hatice Akkurt

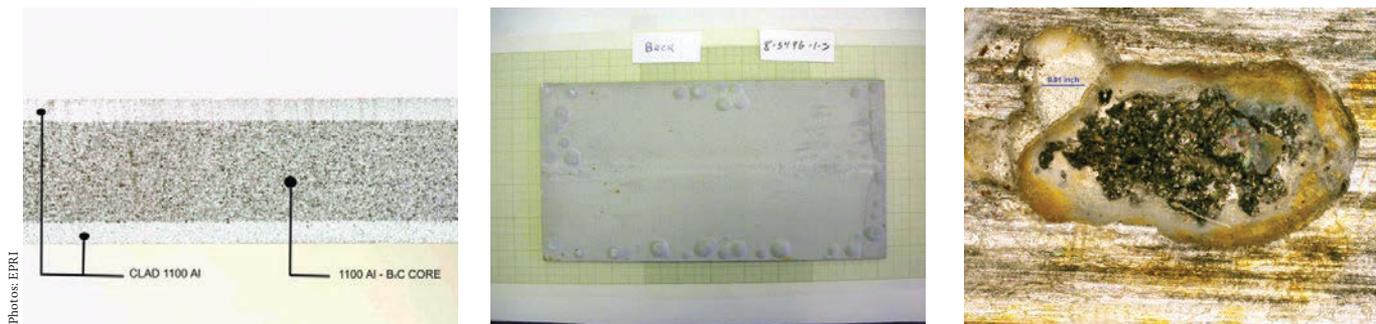
**Fig. 1.** BORAL coupon with (from left) Al cladding on both sides, multiple blisters developed over time, and pitting that breached the cladding.

MMC NAMs are more susceptible to blistering at high temperatures, depending on the material's vintage and porosity. The other MMCs, such as Metamic and Boralcan, do not have cladding; consequently, they are not susceptible to blistering. All of the MMCs are susceptible to pitting corrosion (hereafter, pitting) over time.

As an example, Fig. 1 shows a BORAL coupon with Al cladding on both sides (left), on a coupon that developed multiple blisters over time (center), and pitting with 100x magnification, breaching the cladding (right).

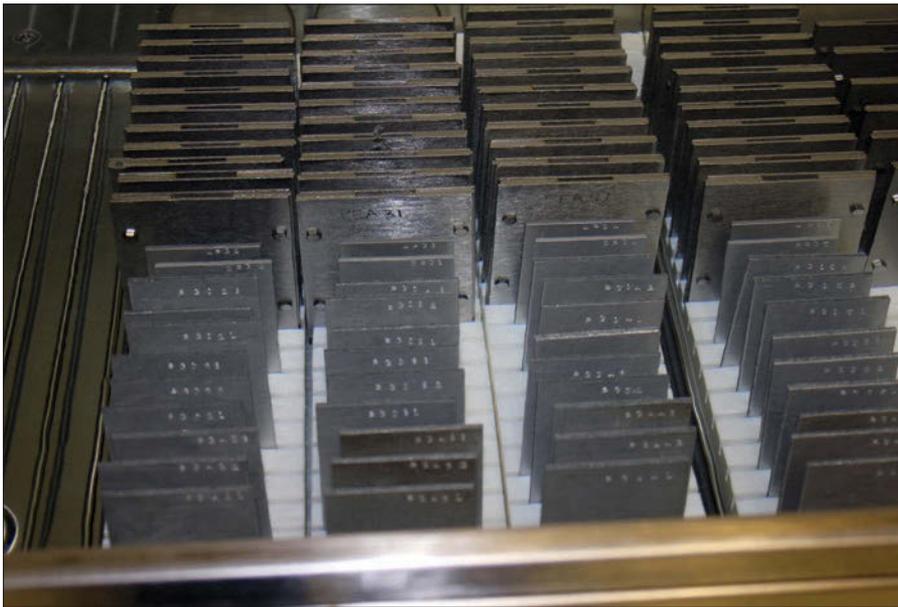
**Fig. 2.** BORAL coupons set in a test bath.

rate. The coupons, bare in the front and with stainless steel (SS) encapsulation in the back, are shown in Fig. 2, in one of the test baths.

Typically, SFP water temperature varies from 27°C to 38°C (80°F to 100°F). The corrosion rate was accelerated by conducting the tests at elevated temperatures, with test baths maintained at 91°C (196°F) to simulate corrosion effects representing more than 60 years of operation during the five-year duration of the study.

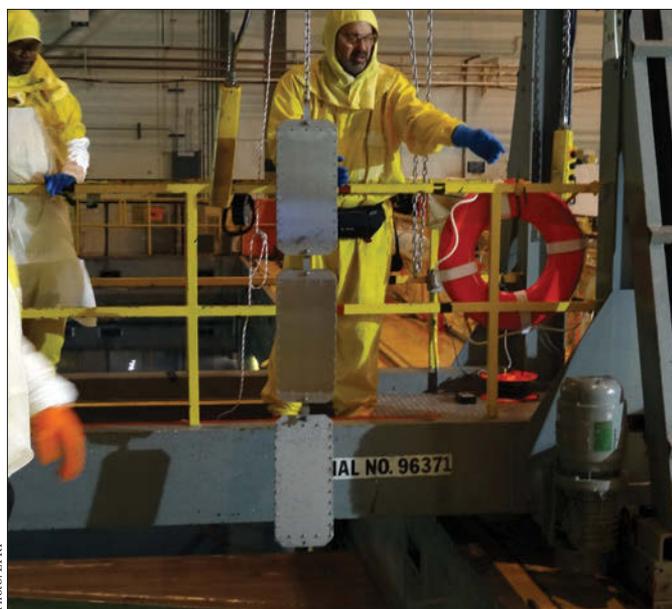
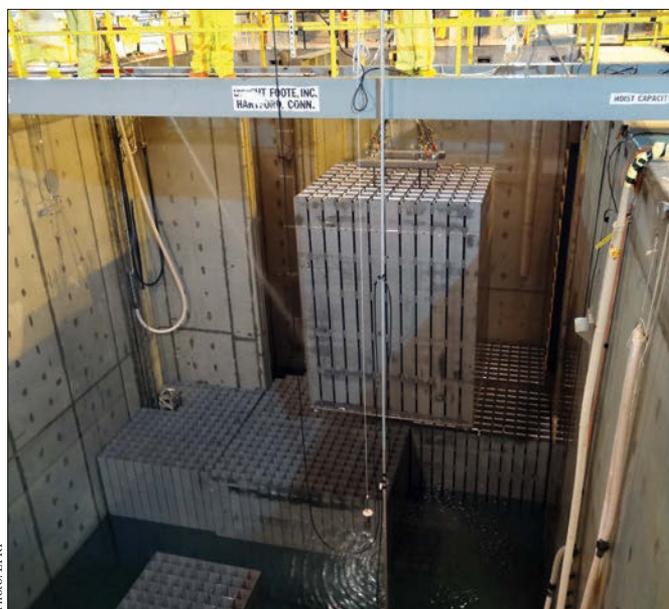
**Fig. 6.** Coupon tree removal (left) and rack module removal (right) from the Zion SFP.

previously, were removed for laboratory analysis and compared against the coupon and *in situ* measurement results. All panels were inspected following removal and cutting. The panels were generally in very good condition. Two of the panels were damaged outside of the pool due to plasma torch cutting and developed blisters. Out of the remaining 12 panels, only one section for one of the panels showed a small blister. The panels showed general and localized corrosion and flow patterns, but nothing that raised concerns regarding their ability to maintain criticality safety margins. Figure 6 shows the coupon tree removal (left) and rack module removal (right) from the Zion SFP.
