Surry's safety-related pipeline upgrade

A seven-year project to renew safety-related piping picks up an industry award as it prepares Surry for long-term operation.

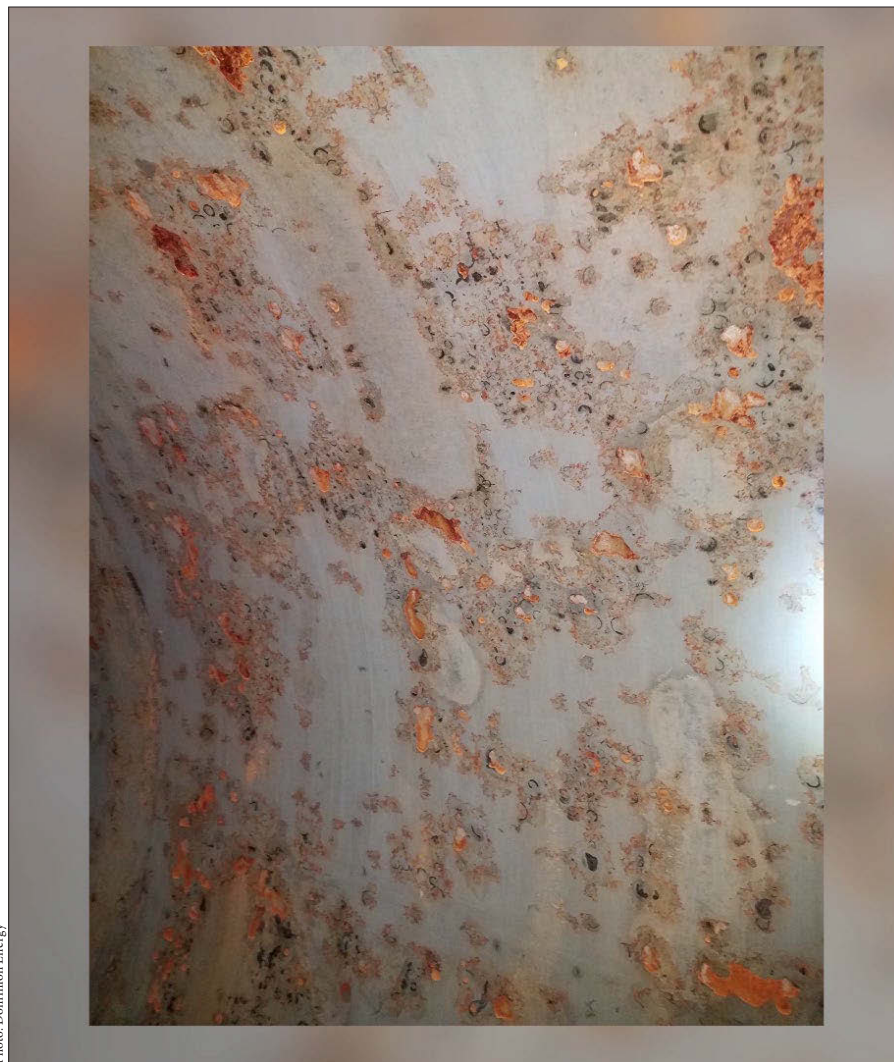
The condition of Surry’s metallic pipelines required routine repair work, driving the desire for a long-term CFRP upgrade.

Over the past several years, routine inspections required by American Society of Mechanical Engineers (ASME) Boiler & Pressure Vessel Code (B&PVC) Section XI, “In-Service Inspections of Nuclear Power Plant Components,” identified significant corrosion on the interior surfaces of the circulating water and service water carbon steel piping. During refueling outages, this piping has been routinely drained, cleaned, inspected, welded, and coated with a ceramic-epoxy coating system. These maintenance activities have proved very costly and have often impacted the refueling outage critical path. Meanwhile, the overall condition of the carbon steel piping has continued to degrade, increasing the possibility of an unplanned outage. After many years of addressing pipe degradation during every outage, Surry needed to find a long-term solution for the affected pipelines.

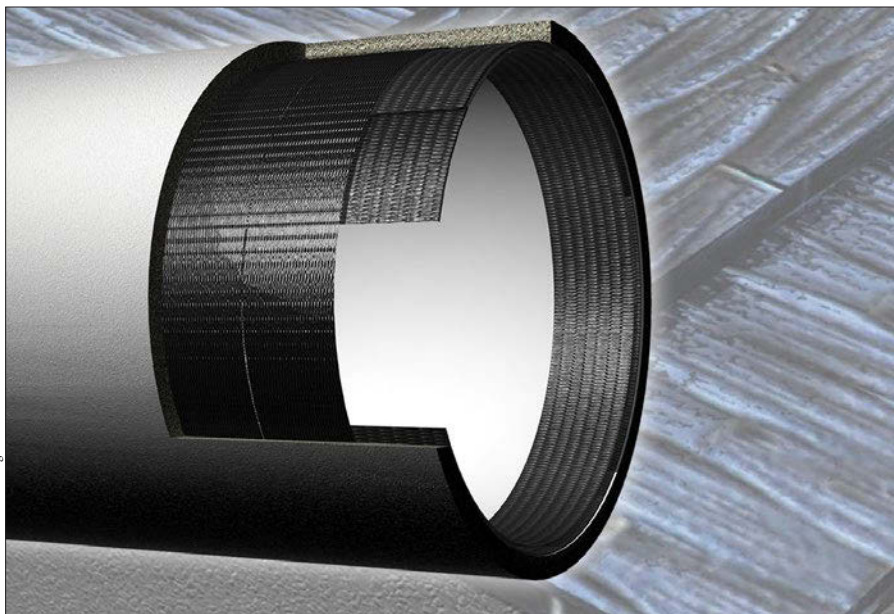
Structural Technologies' V-Wrap CFRP System received approval from the NRC for an upgrade of safety-related pipelines at Surry.

The project team for the Surry pipeline upgrade designed, manufactured, and installed the structural upgrade for the circulating water and service water safety-related piping using Structural Technologies’ V-Wrap CFRP System. CFRP is a lightweight, high-strength composite material applied to the interior of the pipe using existing access points.

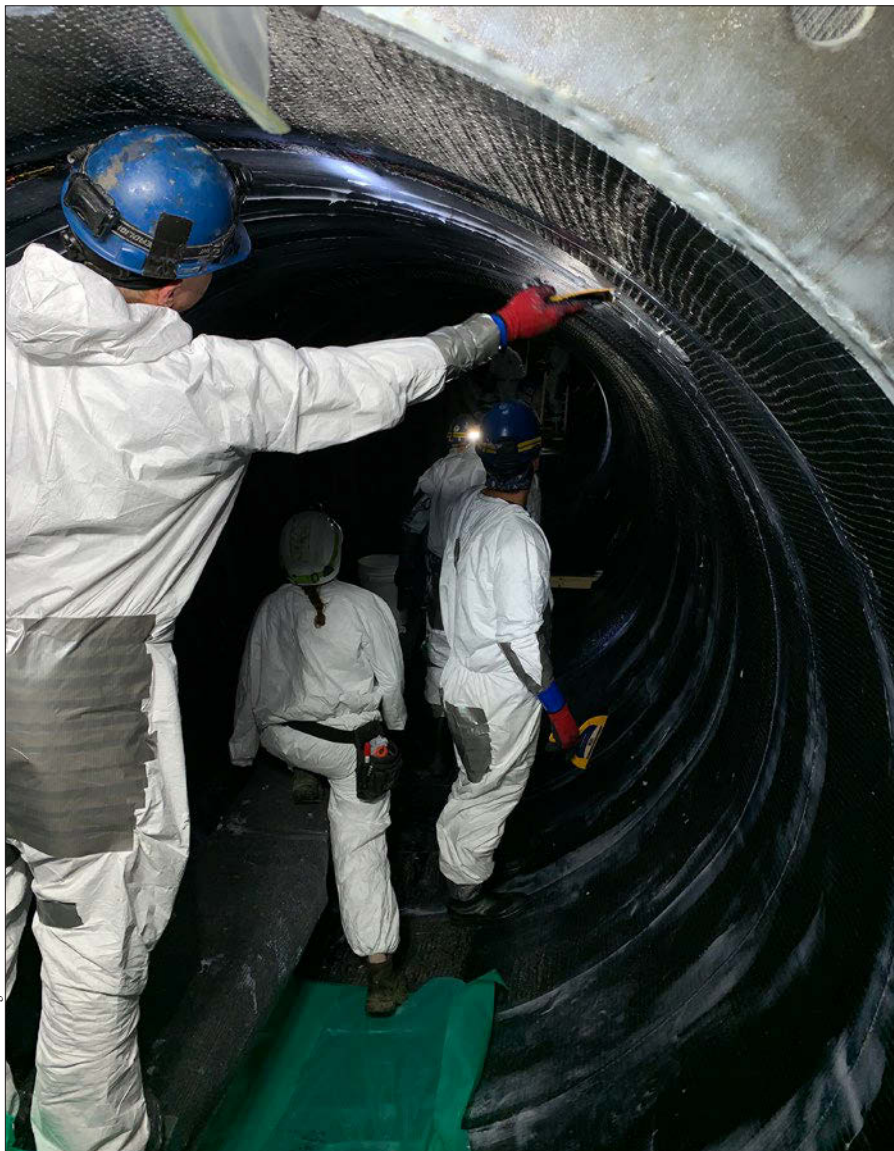
Quality control inspections were ongoing during the CFRP installation process as part of the pipeline upgrade.

The QC procedures in place for the safety-related CFRP upgrade at Surry were robust, setting a standard for the industry. For documentation of the CFRP repair, separate QC forms were created for each segment of pipe repaired. This included identifying the location and specifics of the rehabilitation, design and as-built information, and as-found conditions, such as previous repairs. Each individual QC form documented the complete lining installation process, including the date of completion, inspection/verification of the installation process, lot numbers of materials used, notes regarding unique field conditions, and the personnel involved in the QC documentation process.

Verification of the installation process consisted of a series of tests conducted throughout the installation phase, including saturator roller calibration, a weight ratio test to verify epoxy saturation, testing of the bond and the tensile strength of the CFRP, and cure testing to verify that the CFRP system is fully cured prior to placing the piping back into service.

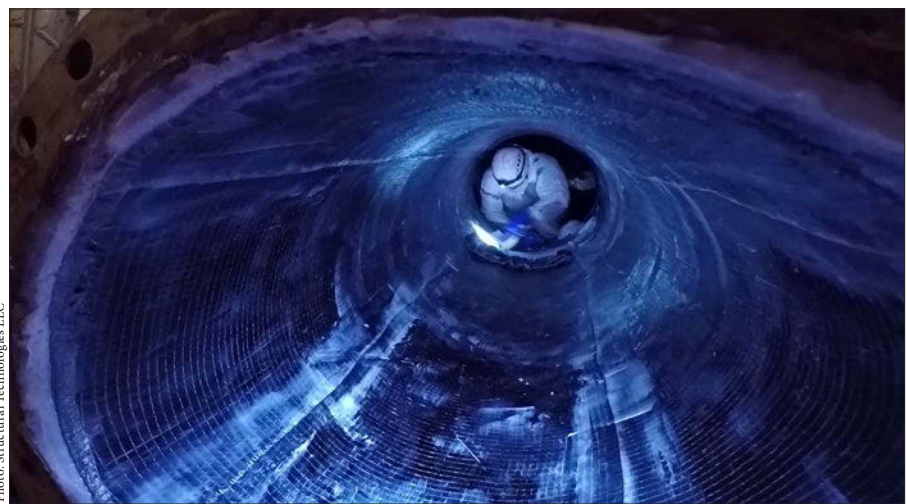
A trained and certified technician, meeting Surry specification requirements, installs the CFRP system in a 30-inch segment of piping.

The saturated CFRP is applied to the inside surface of the host pipe in what is called a “wet lay-up process.” The fabric, fully saturated with epoxy, is pressed to the inside surface of the host pipe to achieve intimate contact. Any air trapped between layers is released or rolled out without wrinkling of the carbon fiber. The installed CFRP is oriented in the directions indicated on the design drawings, with no greater than a five-degree misalignment of the fabrics allowed from the specified direction.

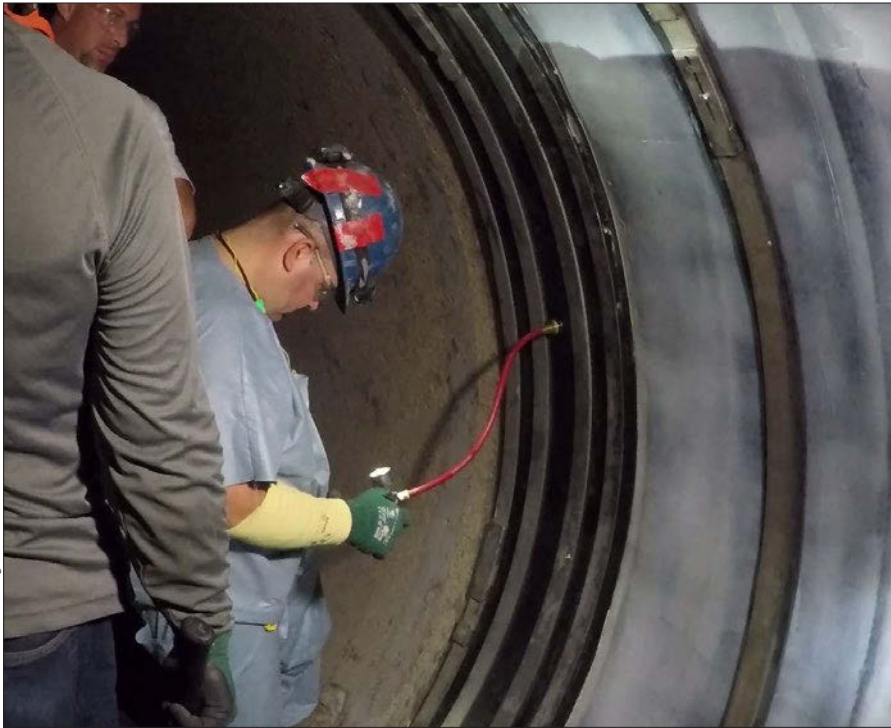
Custom-designed termination points are critical to the long-term performance of the CFRP lining system.

Following the installation of the CFRP system at Surry, the termination points were installed. The termination points of the CFRP liner are a critical point of the lining system, and they are designed so internal water pressure is not able to migrate behind the CFRP system. If the CFRP is not properly sealed at termination points and pressure is allowed to build up behind the liner, the CFRP lining will be structurally ineffective. In addition, a topcoat of thickened epoxy is added as the final layer across the entire installed CFRP system. Following these steps, the CFRP system is cured and the installation is complete, following quality control (QC) sign-off.

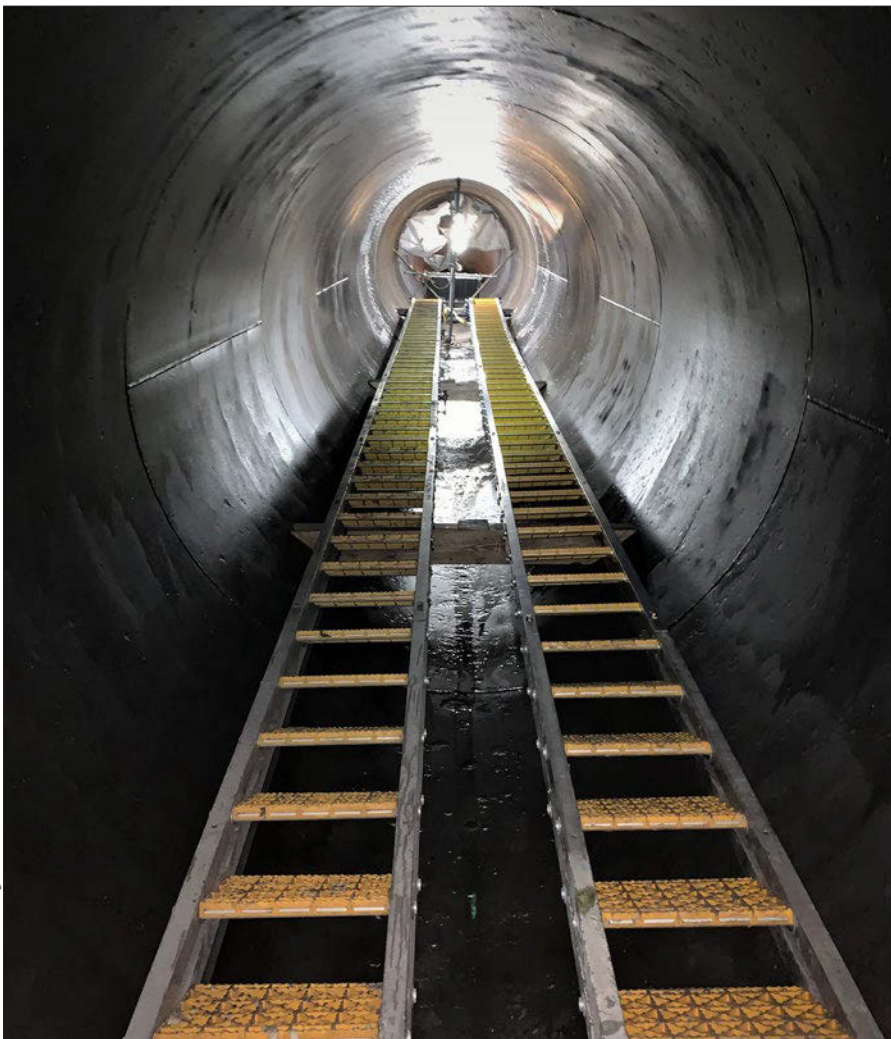
Specialized access systems were required for safety during the CFRP upgrade of sloped pipe segments.

is staged to avoid contact with the material until it has cured, which takes about 72 hours in ambient temperatures. In the 96-inch piping upgraded at Surry, a temporary platform was installed to allow for continued access and completion of the CFRP installation process.

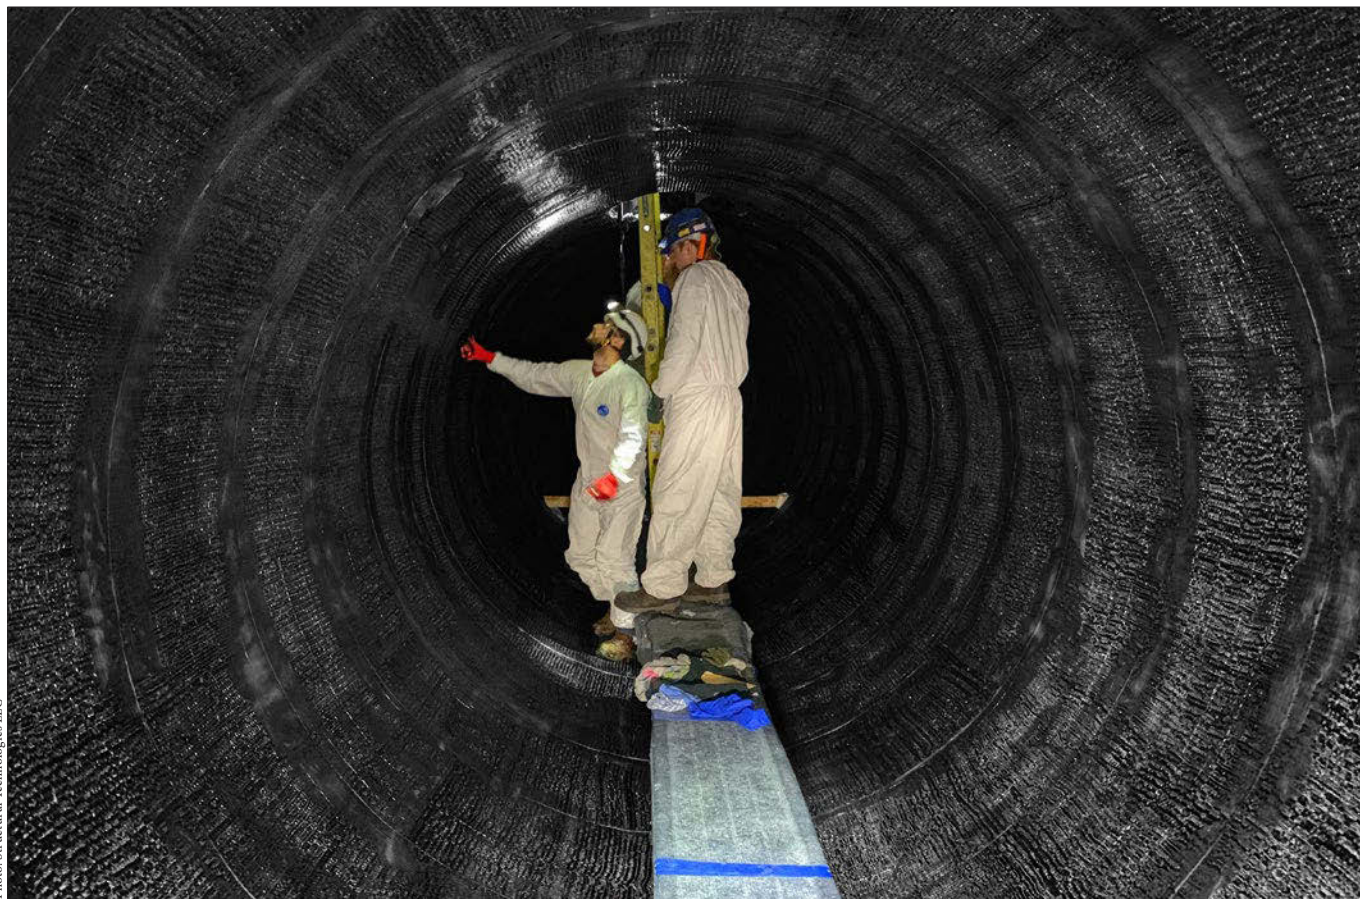
Quality control inspectors carry out a detailed post-installation examination of the installed CFRP lining system.
